WILD TROUT TRUST  
wildtrout.org

## Advisory Visit River Sid, Devon

April 19, 2021

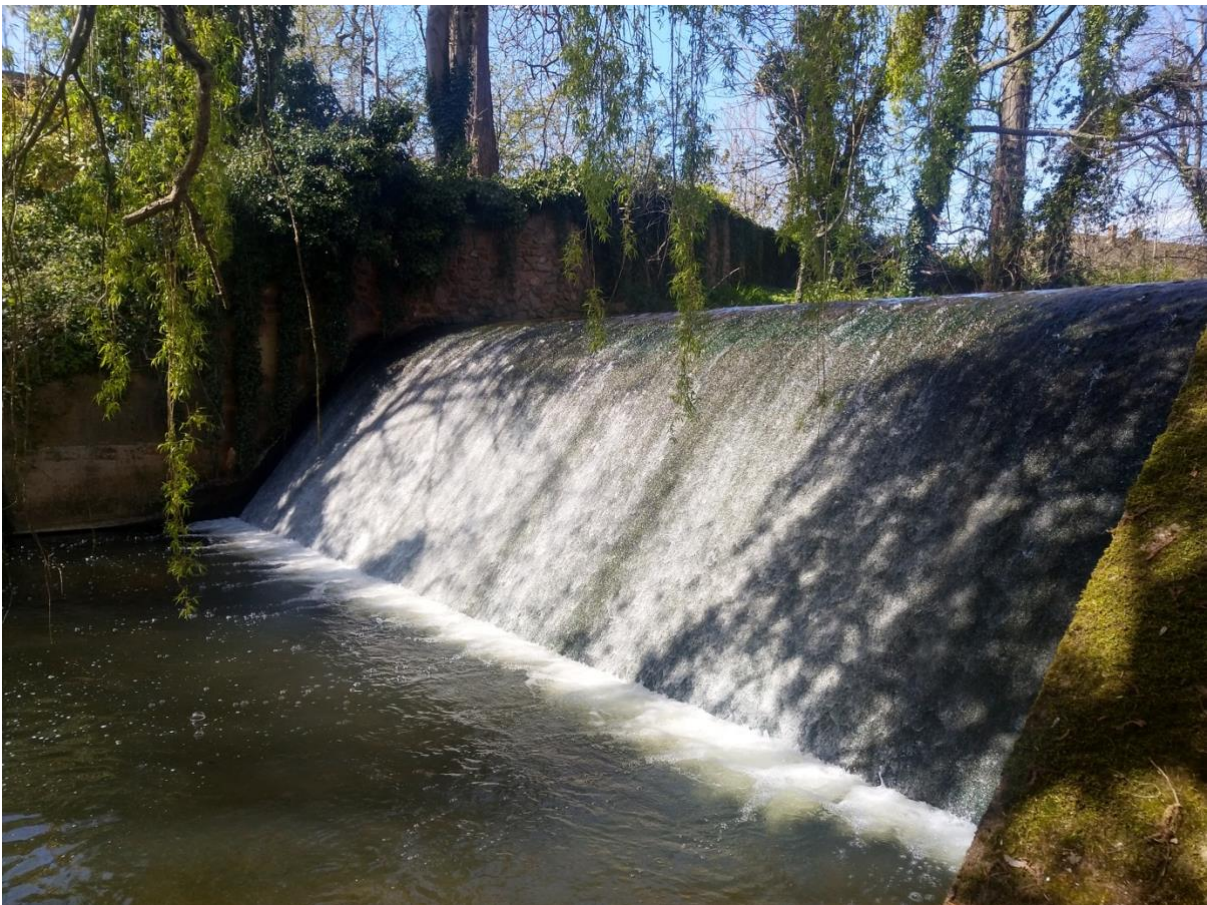
*Figure 1 School Weir*

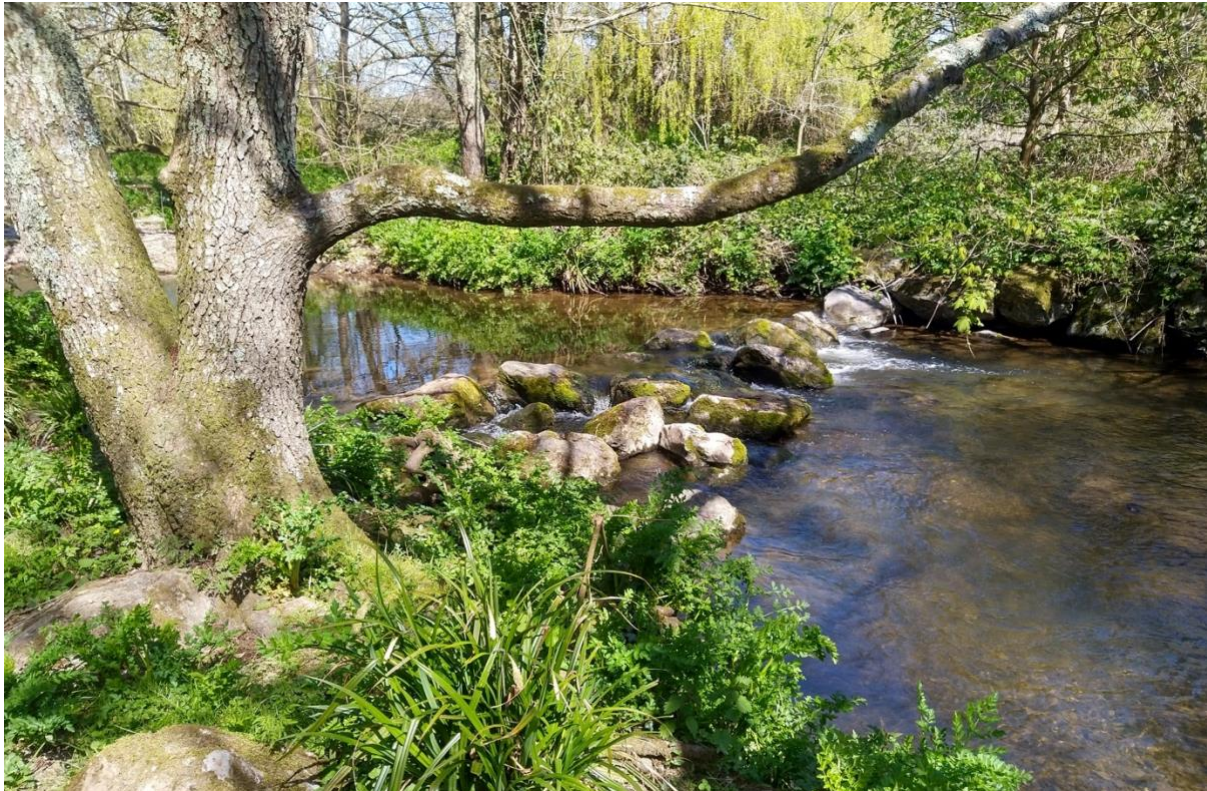
*Figure 3 The first boulder weir immediately upstream of another at Figure 4. This should be altered with an aim to provide general roughness, over the appearance of a weir. SY 13304 88965*

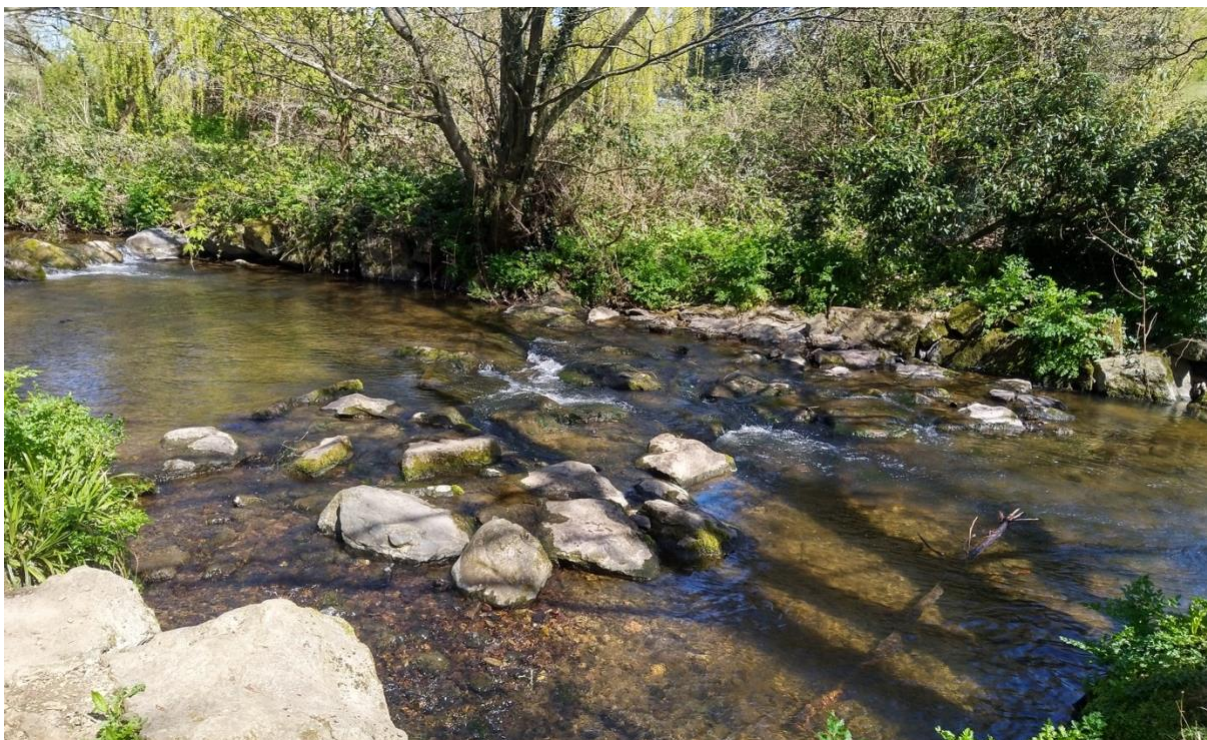
*Figure 4 Immediately downstream of Figure 3 (visible top left), a more sympathetic artificial riffle. Though better, it could still benefit from manipulation. SY 13307 88965*

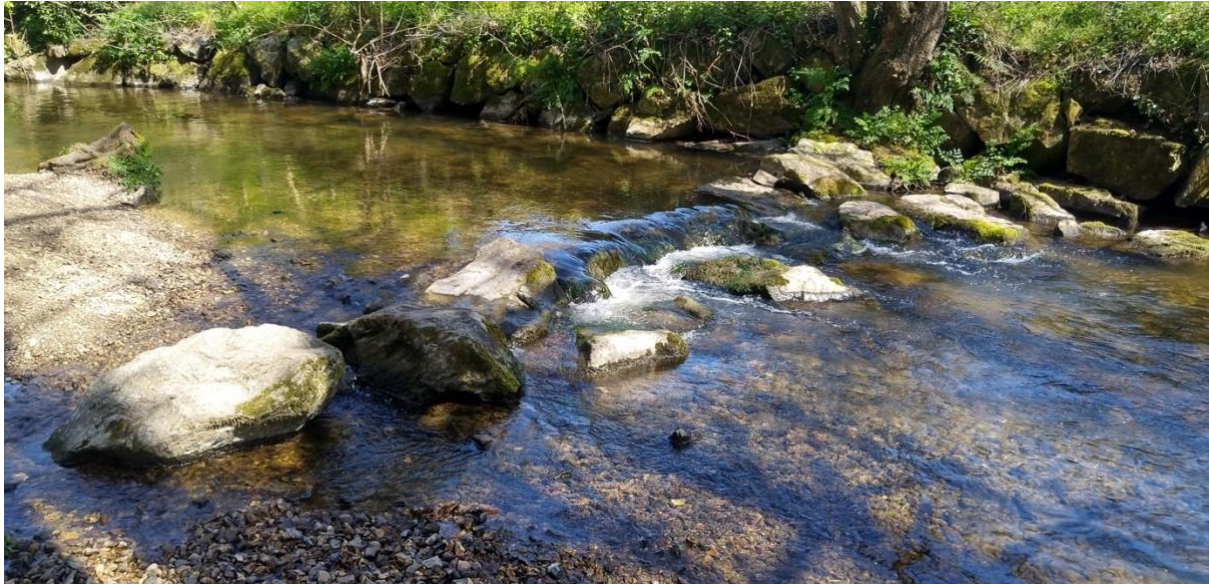
*Figure 5 Another boulder weir. Simply encouraging low flows around the last boulder on the RB (nearest to camera) would begin a meander while still allowing high flows to pass over the top. SY 13307 88965*

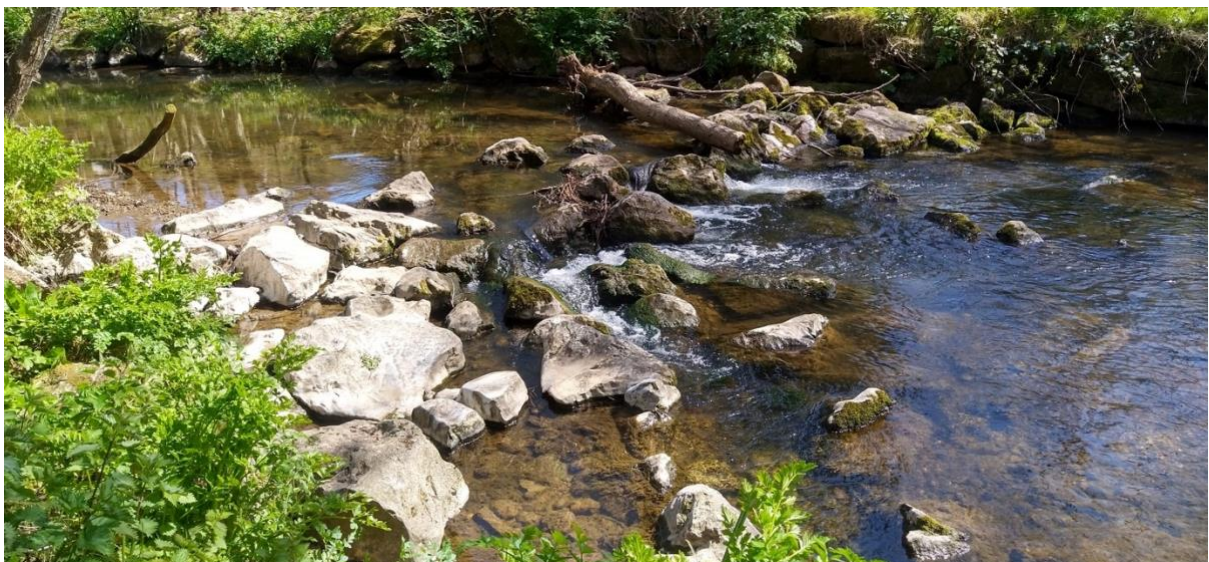
*Figure 6 Another boulder weir. Note the uniform depth and sediment upstream compared to the diverse depth and substrate downstream. Such uniformity increases the risk of smolt predation by piscivorous birds. SY 13289 88913*

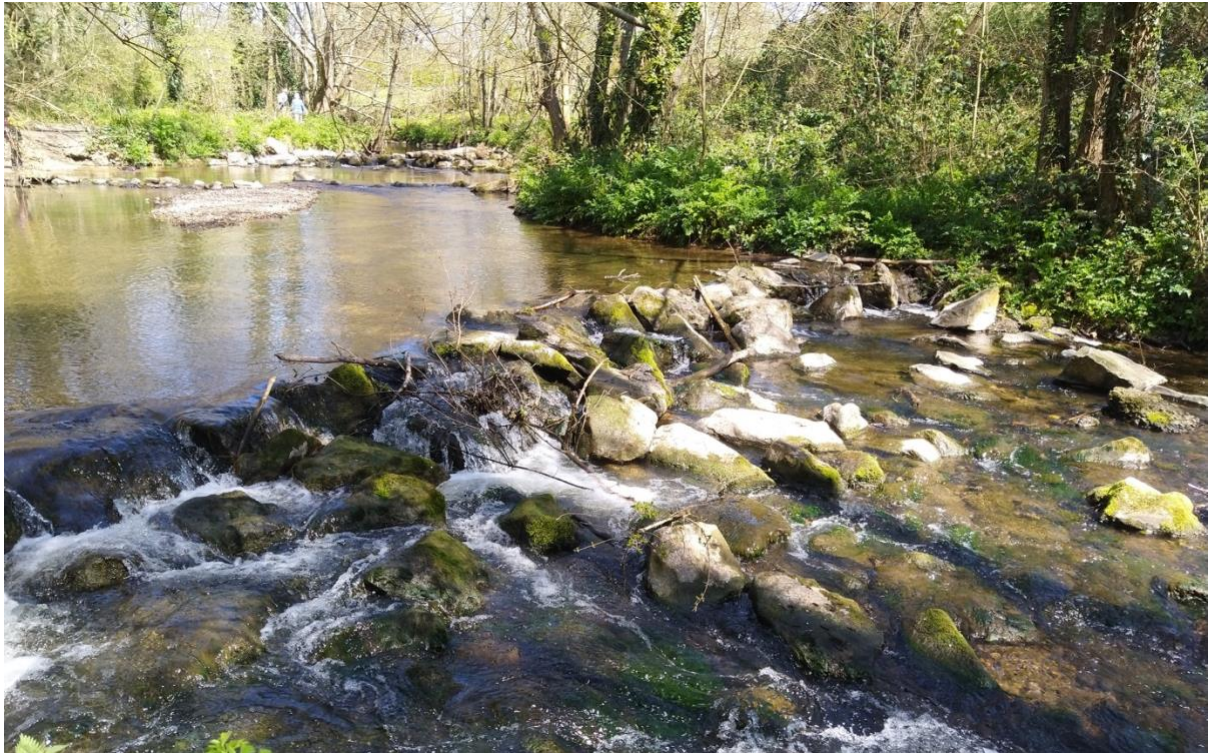
*Figure 7 A cascade of several boulder weirs. SY 13279 88875*

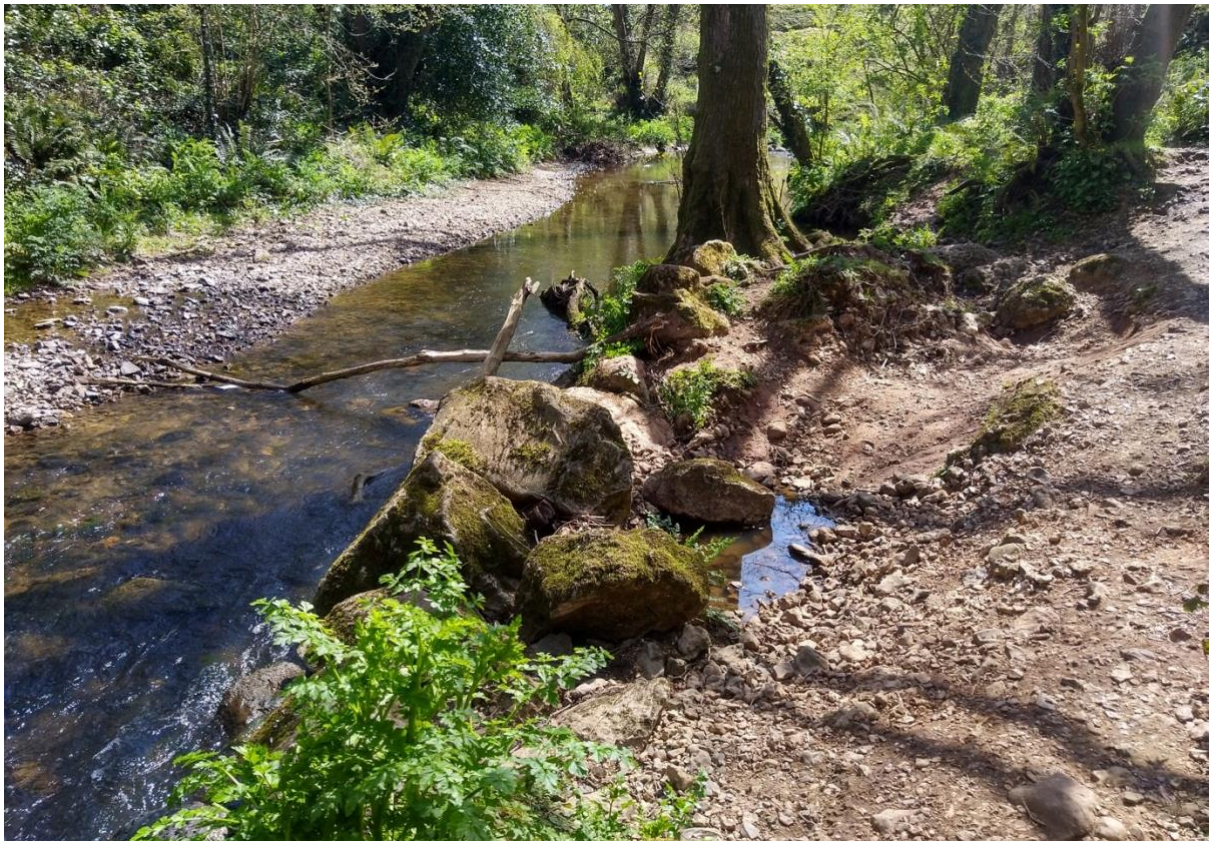
*Figure 8 Erosion is beginning to cut around the back of this tree. Considering the straightness of the channel downstream, this could be a place to encourage a bend by manipulating the boulder weir immediately upstream. Felling the tree across the channel could arrest flows and help with the diversion. SY 13279 88875*

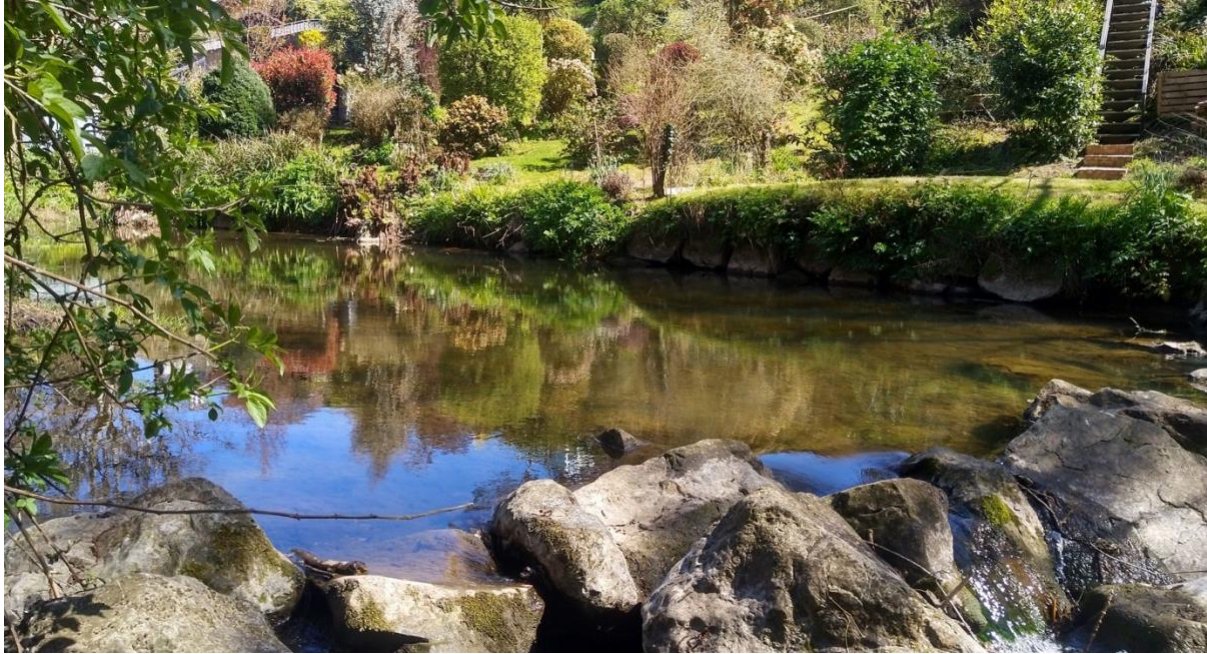
*Figure 9 Another boulder weir. Note the impoundment of the river above and the stone revetment of the garden banks. This calm water may be seen as desirable for the bankside gardens but is detrimental for the habitat. SY 13171 88701*

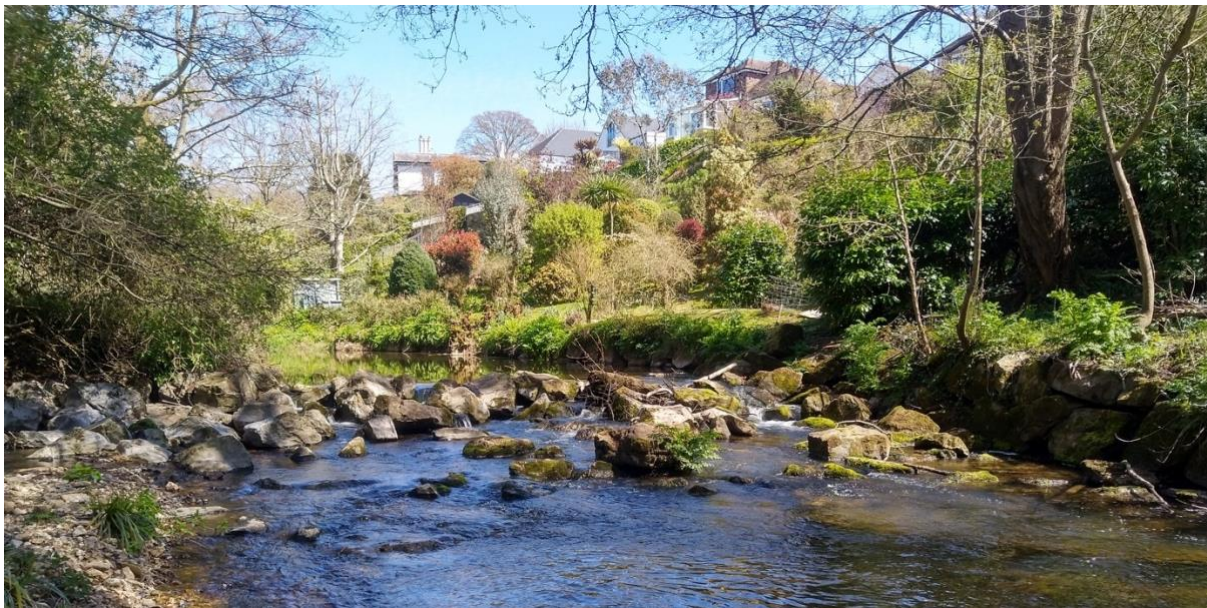
*Figure 10 Easing of this boulder weir will increase the pace of flow in the impoundment by the gardens (as seen in Figure 9). Work will be needed to prevent erosion of their banks, but the river course could be encouraged toward the RB. SY 13171 88701*

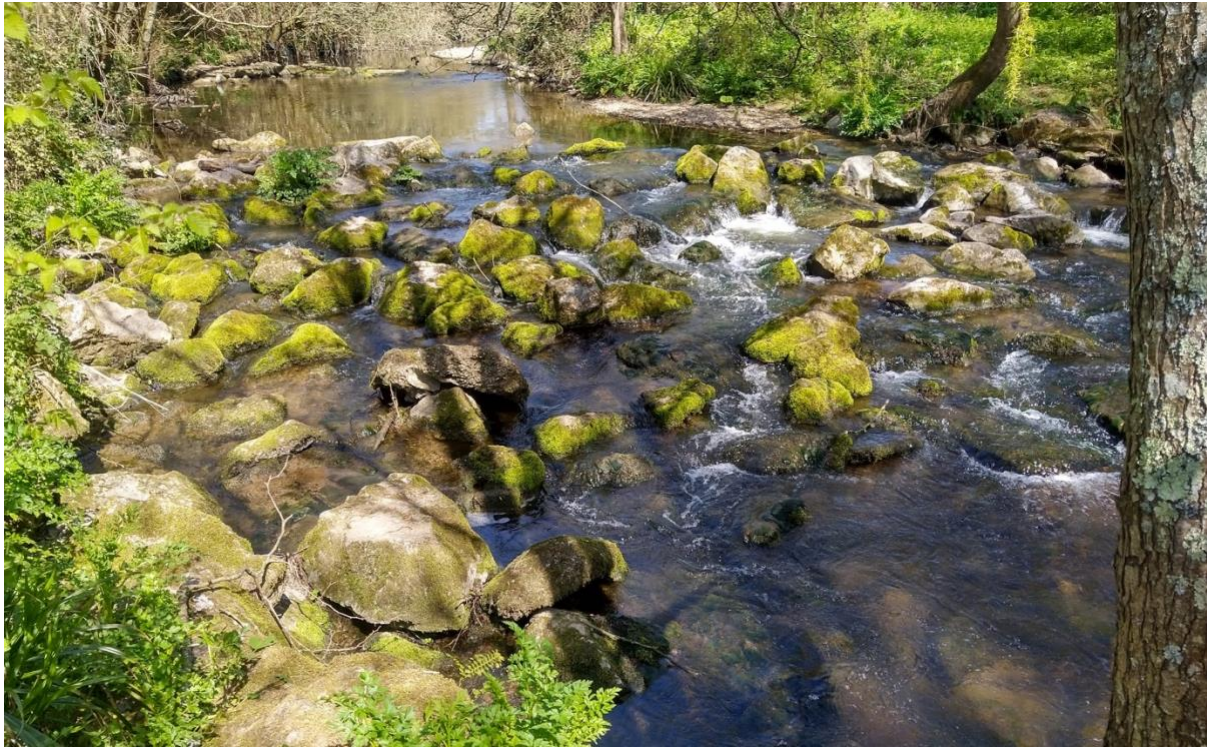
*Figure 11 A more natural looking, yet man made, boulder weir. Better placement of rocks could allow the river to traverse across its width. SY 13171 88701*

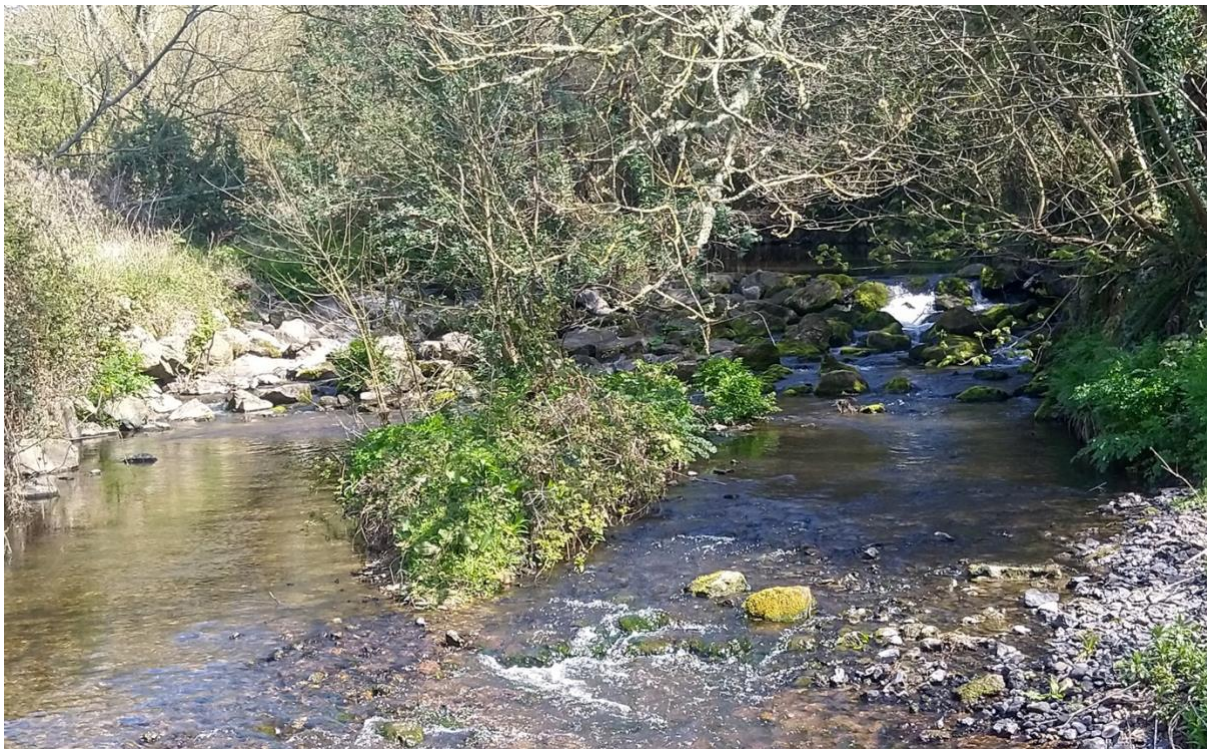
*Figure 12 The largest of the rubble weirs visited. Note the natural riffle in the bottom of shot. Such habitat is rare on the reach, being drowned out by the artificial weirs. As juvenile habitat, it is important to allow such habitat to exist. SY 12992 88628*

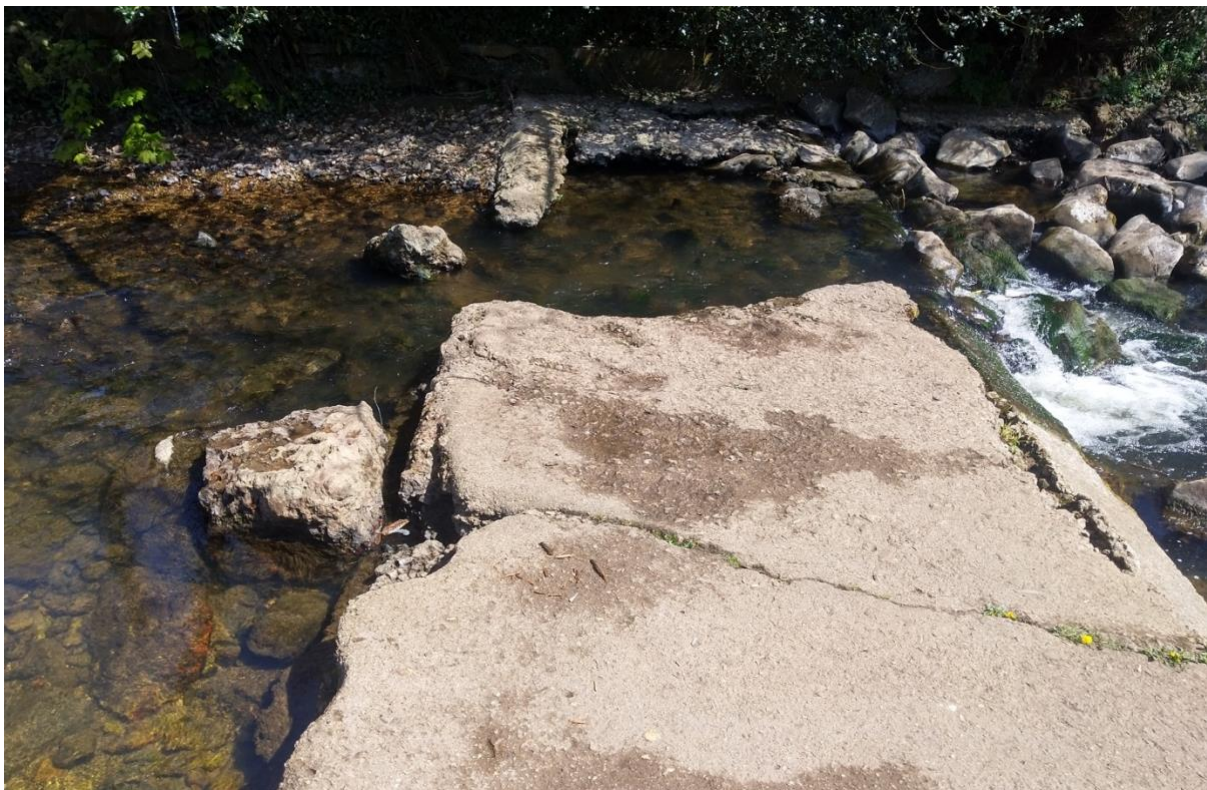
*Figure 14 The remains of an old weir structure. Despite the breach, it is impounding the reach above and could be entirely removed. SY 12956 88575*

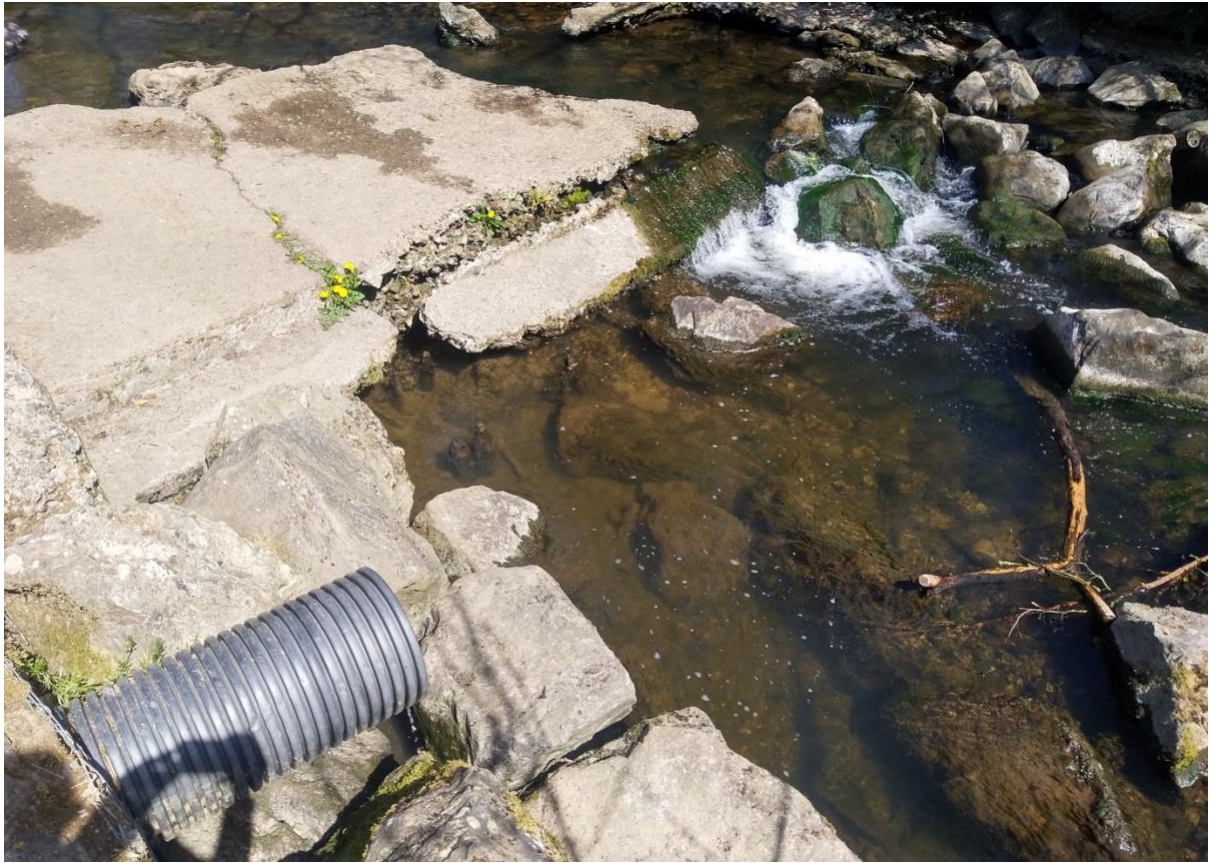
*Figure 15 Sewer Storm Overflow Permit No: 201828 no spill duration monitoring available. Algal growth suggesting excessive nutrients in this area. SY 12956 88575*

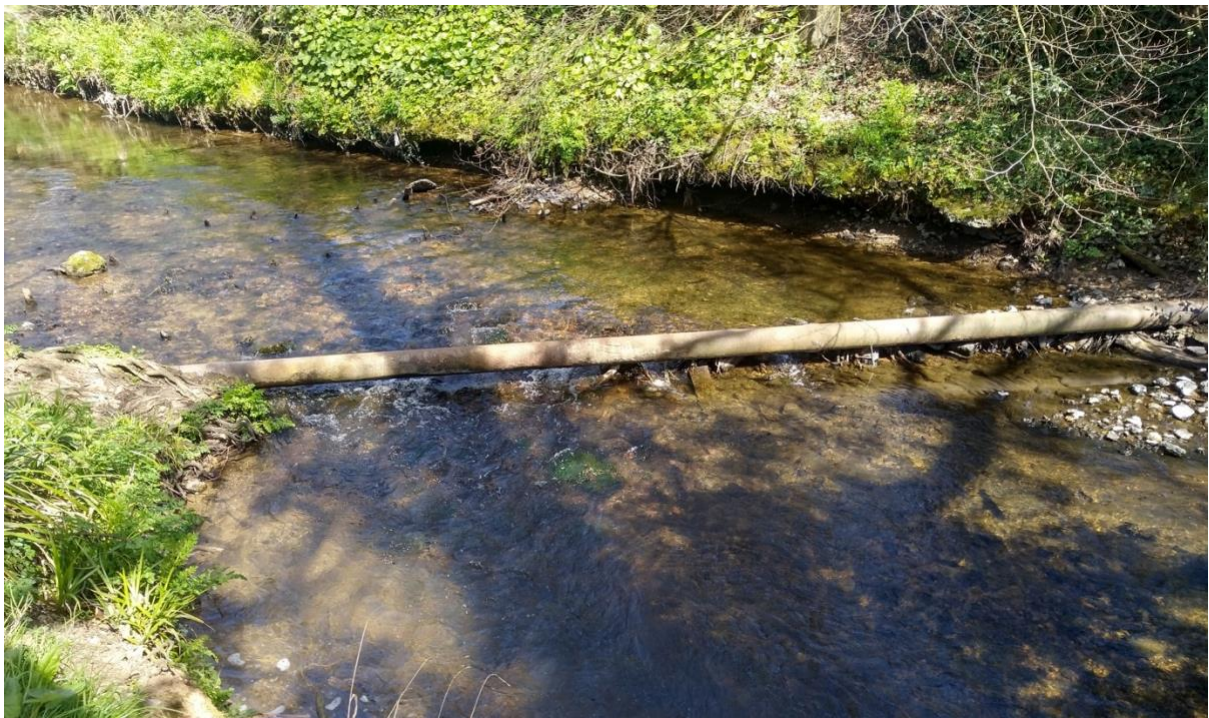
*Figure 16 A sewerage pipe crosses the river. With high flow velocities common, this is vulnerable to fracture by passing debris. The asset owner is liable for the environmental damage such a fracture will undoubtedly cause downstream. Liaison with the owner to find a re-routing solution is advised. SY 12977 88539*

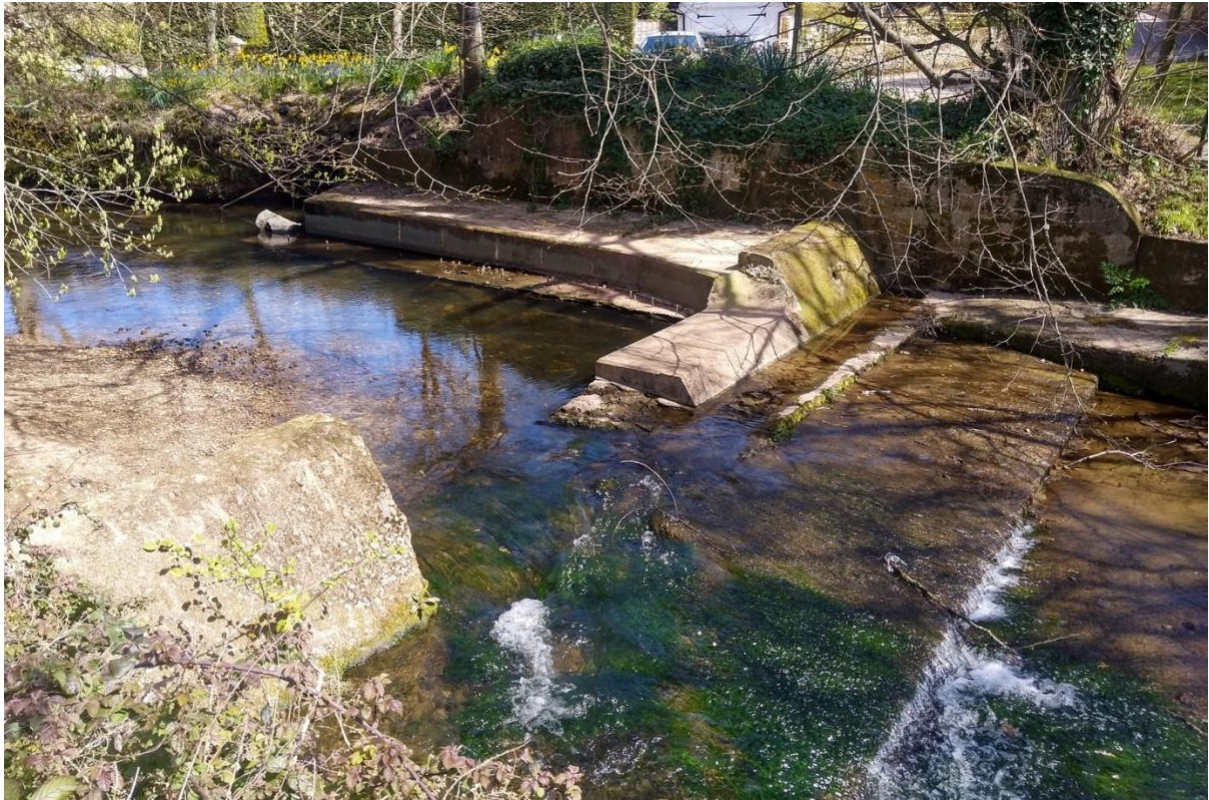
*Figure 17 Another old weir that has had a section removed. Despite this improvement for fish passage, the three shallow steps downstream are a significant impediment to fish passage. Total removal would be the best course of action. SY 12969 88498*

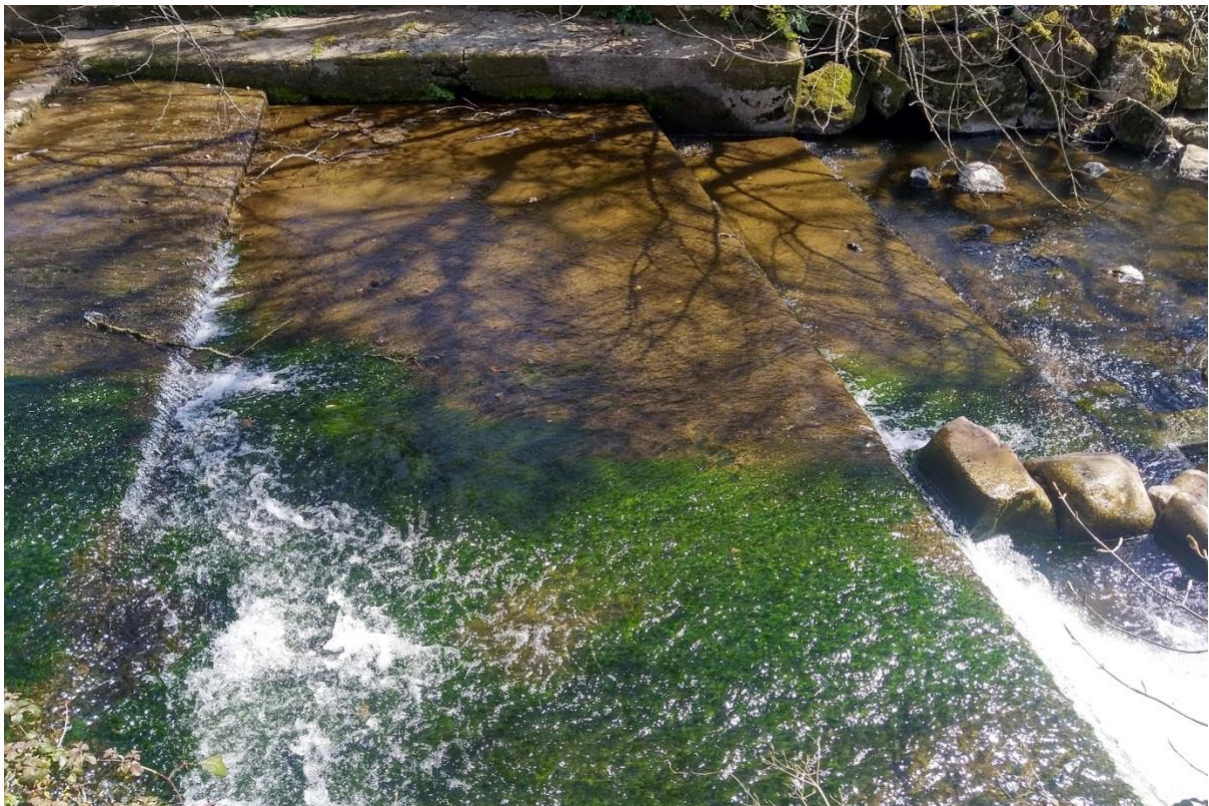
*Figure 18 The three shallow steps downstream of the weir in Figure 17. In low to medium flows, there isn't enough water for fish to swim upstream. SY 12969 88498*

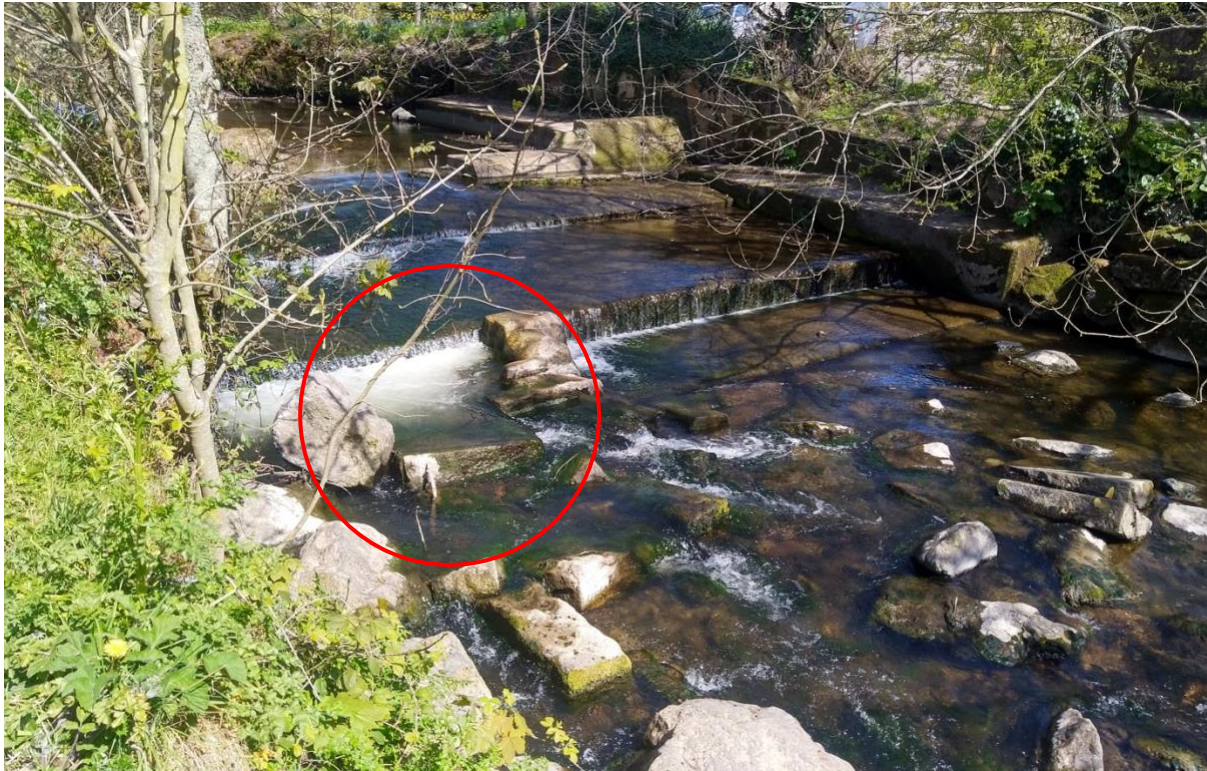
*Figure 19 Looking upstream to the weir in Figures 17 & 18. A notional jumping pool has been created to ease the first step (red circle), but overall insufficient to allow good upstream fish passage. SY 12969 88498*

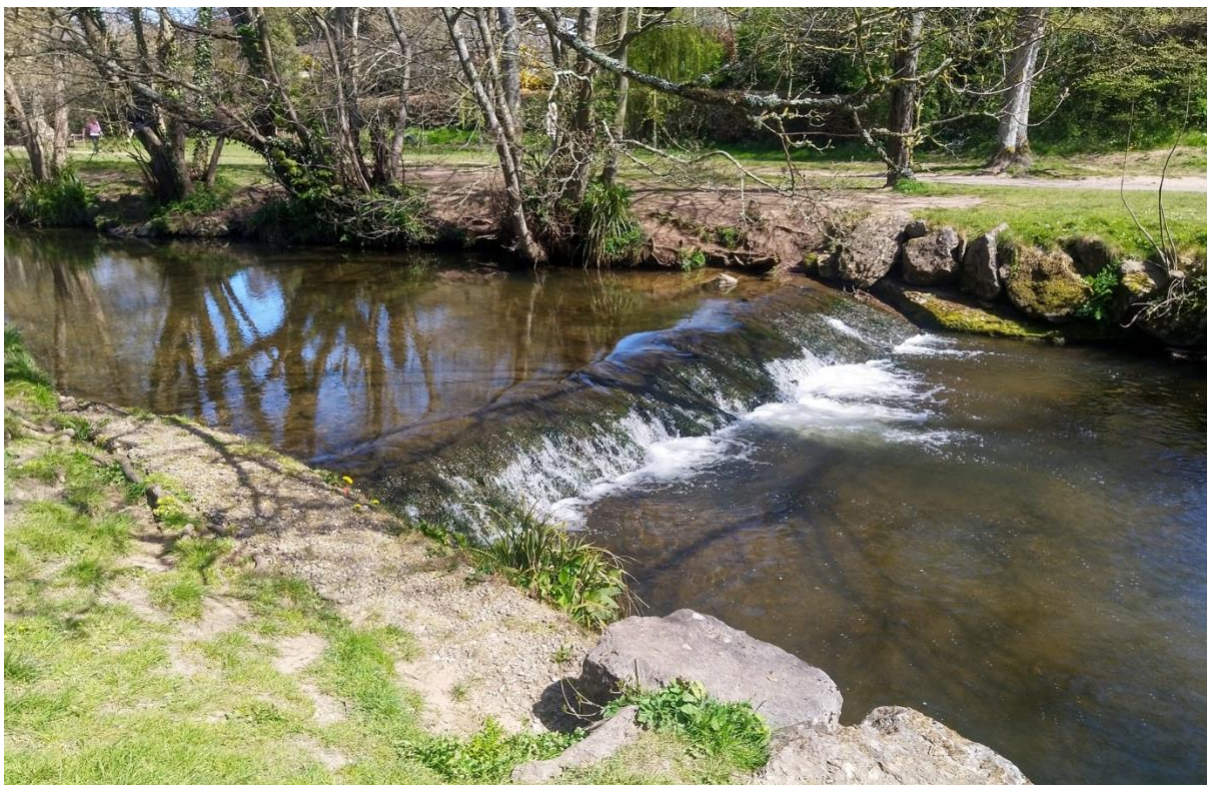
*Figure 20 A slightly more conventional Check Weir. Though not impassable, it still presents an unnecessary stress and delay to upstream and downstream migration. The impounded reach above is also severely lacking habitat diversity caused by the impoundment. Removal or significant alteration is recommended. Adding large woody material (LWM) would also be beneficial. SY 12880 88343*

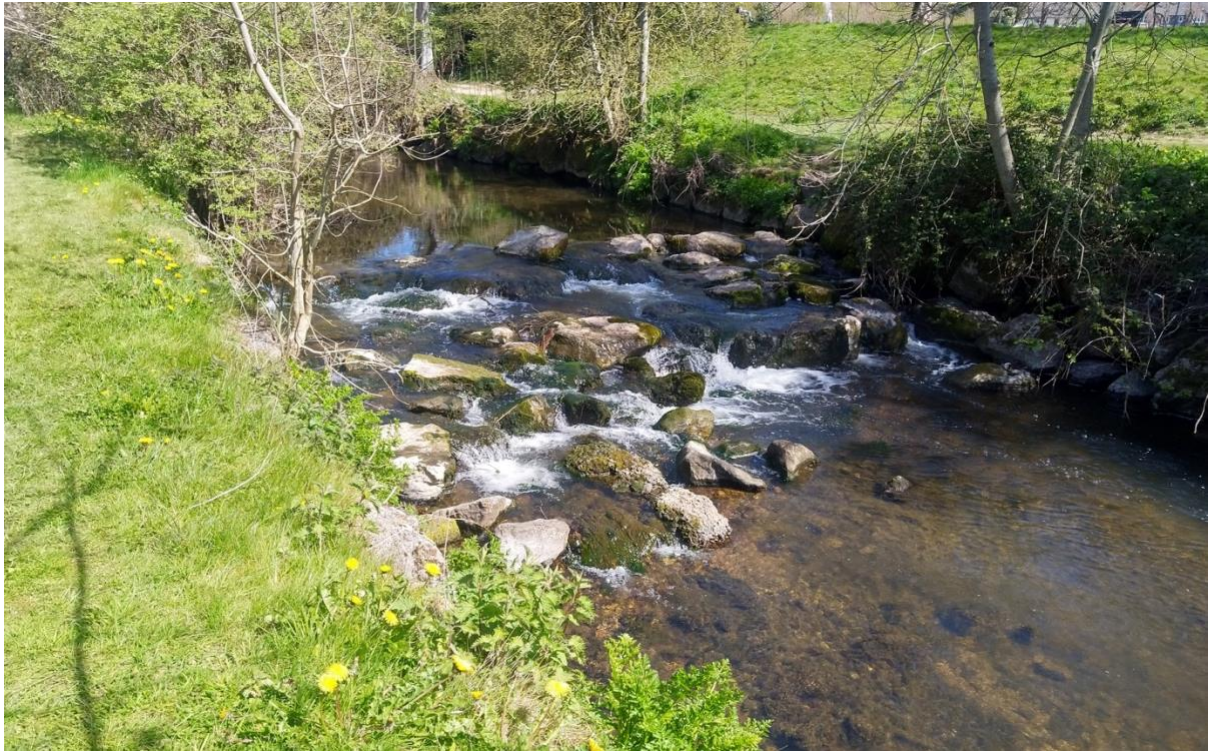
*Figure 21 A better looking rubble weir, though still an unnecessary impediment to natural river function and fish migration. With room on both banks, the gradient could be reduced through meandering rather than an unnatural step. This would restore a lateral scour pool and riffle sequence, good for all salmonid life stages. SY 12863 88312*

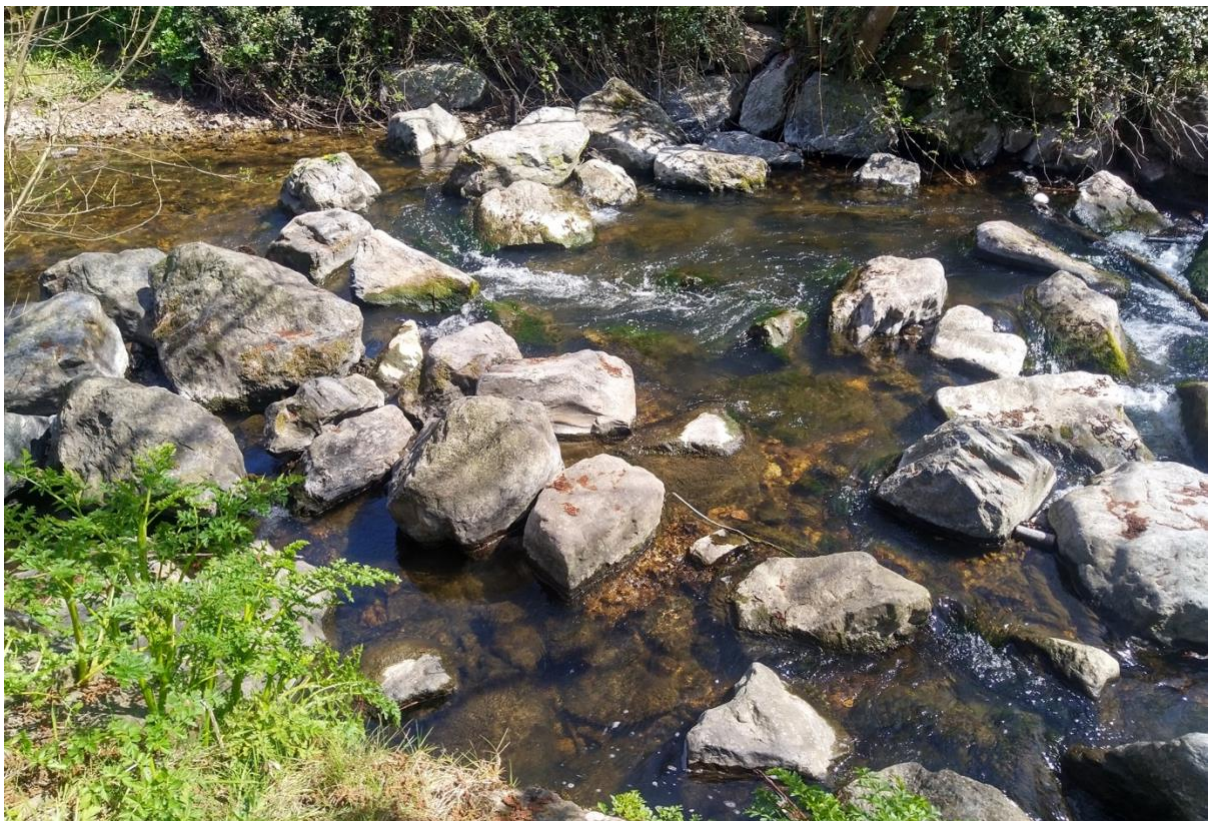
*Figure 22 Directly downstream of Figure 20, another reasonable rubble weir. Again, this could be made redundant (at least partially) through meandering. SY 12852 88305*

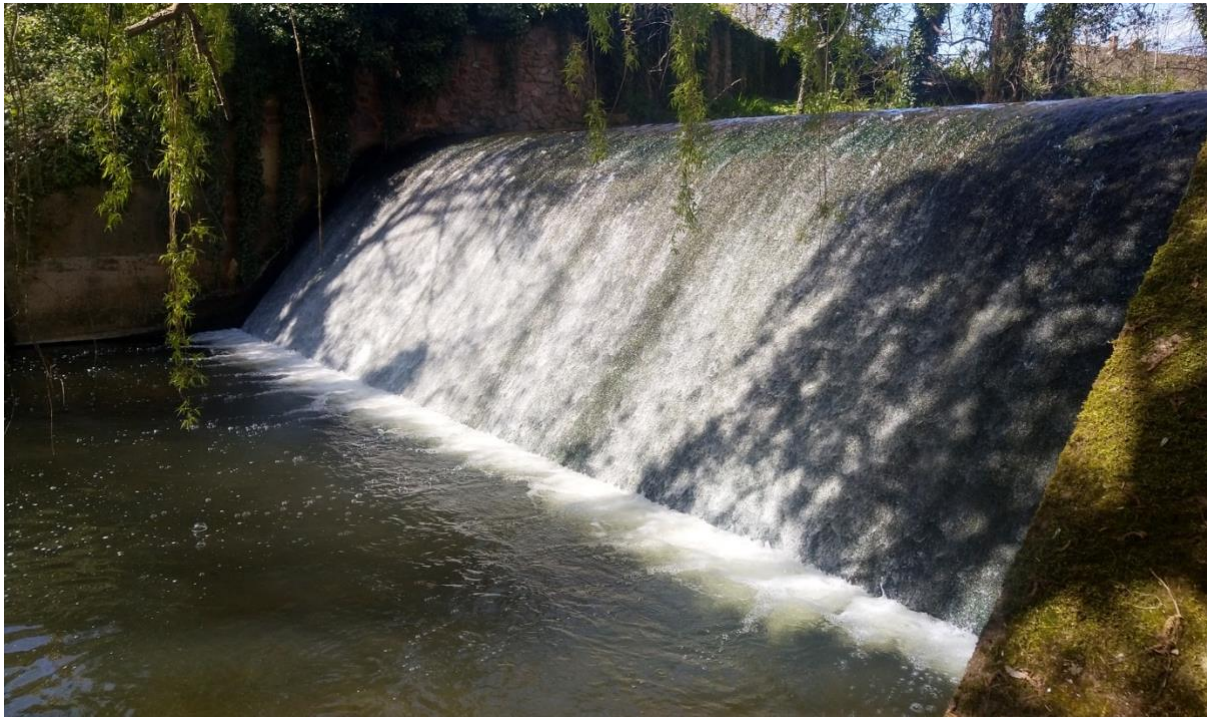
*Figure 24 School Weir seen from downstream. At around 3m high, it is beyond the scope of any salmonids to ascend without help. SY 12790 87895*

The current School Weir is an Ogee type, standing at around 3 metres tall, likely built against the downstream end of the original mill weir. Total removal is unlikely as the reduction in river height upstream would leave gardens and the public space, The Byes, dangerously perched above the river.

Should the old weir be structurally sound, a cascade of smaller weirs could be created with associated notches to allow passage in the greatest range of flows. e.g. reducing the old weir by around 1m and School Weir by approximately 2m. To augment this further, any remaining height on School Weir (after reduction) could be softened with a bolder/rock ramp. Though not ideal, an alteration such as this should greatly improve upstream and downstream migration in combination with better natural river function for the entire reach.

To maintain bed height upstream of the weir, artificial riffles may be needed to control the increased gradient (around 1:70), though a more sinuous channel form could be utilised also (reducing gradient by about 12% based on the conceptual path described above).

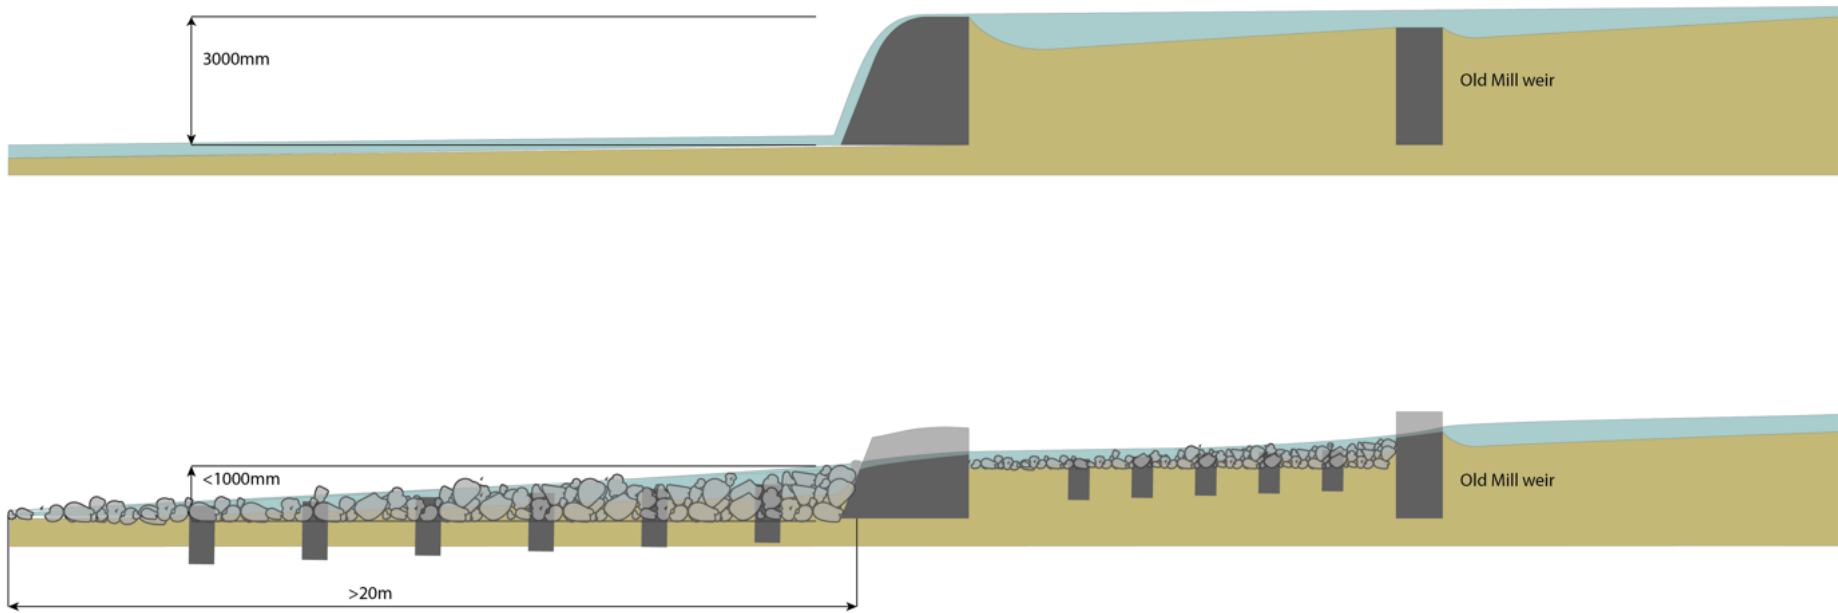
Figure 25 A side view of a possible solution. Lowering of the old weir in combination with significant lowering of School Weir, could bring the gradient within tolerance. The construction of a rock ramp in between and downstream of the weirs will augment the design to provide the maximum range of passability. The heritage status of the old weir and its structure would need to be assessed to take this forward.

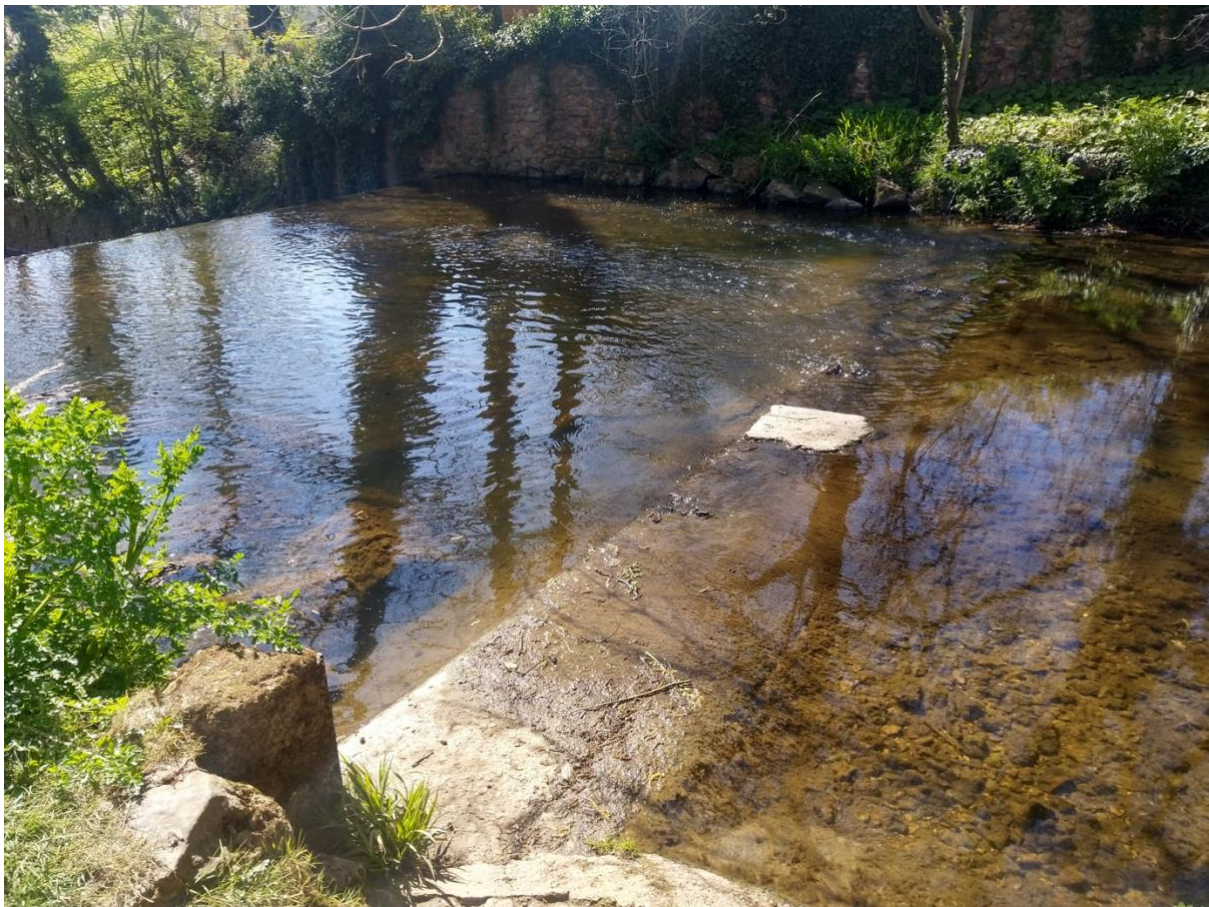
*Figure 26 The old mill weir, approximately 10 metres up from School Weir. With lowering and notching, this could form the first part of a cascade to ease passage while limiting the lowering of the river upstream. SY 12790 87895*
