WILD TROUT TRUST  
wildtrout.org

## Advisory Visit River Sid, Devon

April 19, 2021

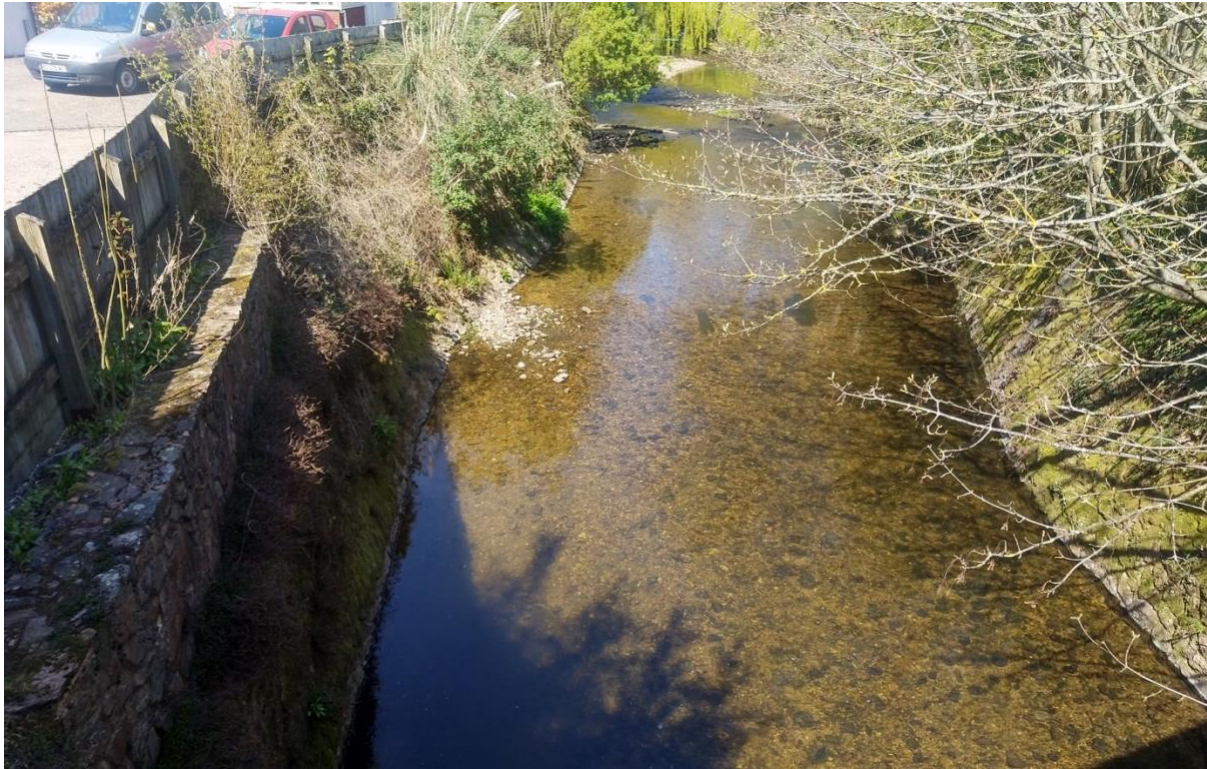
*Figure 29 Looking upstream from Salcombe Rd Bridge. The hard engineered channel and reduced sediment load have contributed to a uniform and featureless channel. In combination with river and weir improvements upstream, low lying large woody material (LWM) could bring back some habitat diversity without affecting high flow conveyance. SY 12781 87811*
