River Sid, Sidmouth, Devon

A Project Proposal by the Wild Trout Trust April 2023

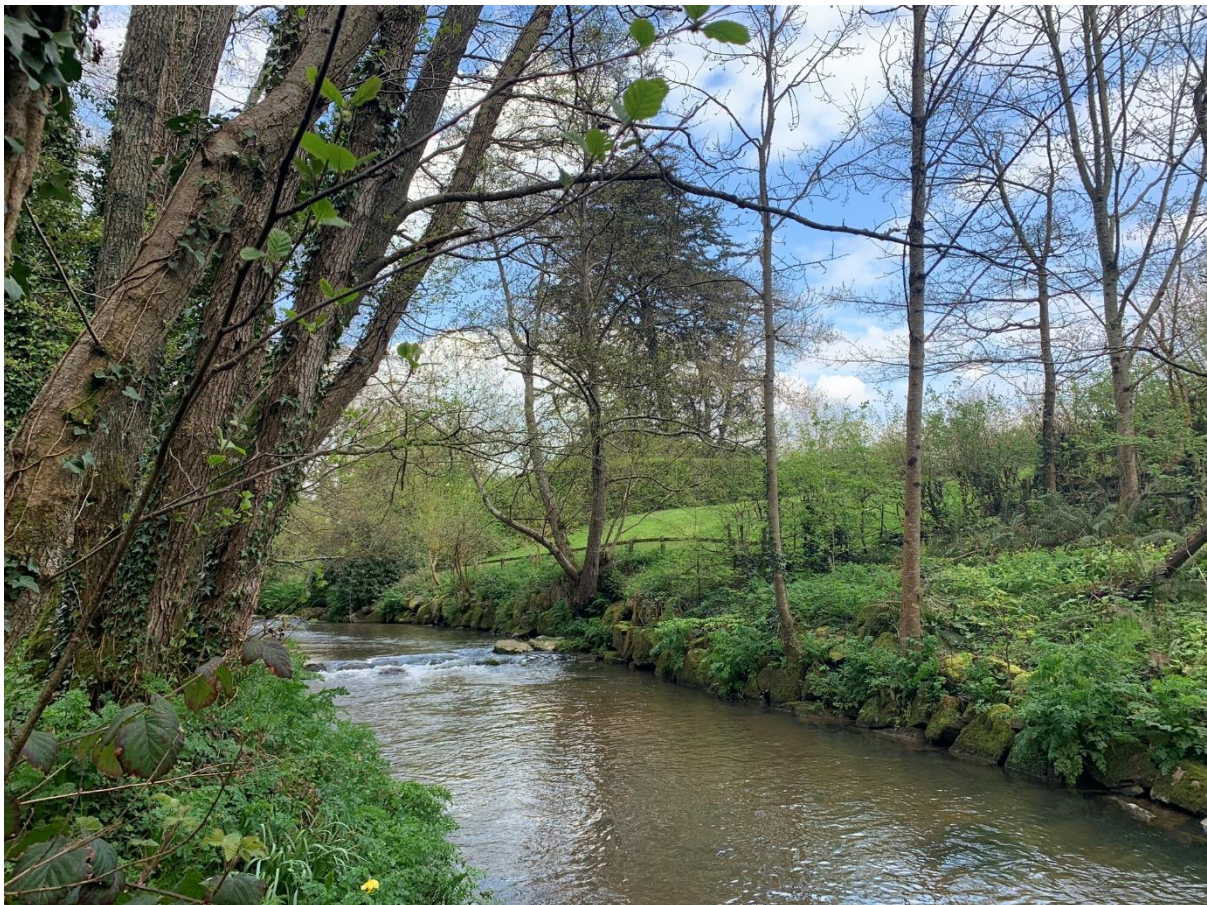
Figure 2: The river alongside Gilchrist Field is artificially straight and uniform in bed profile. The LB is armoured with boulders and mature alder trees area casting dense shade over the river.

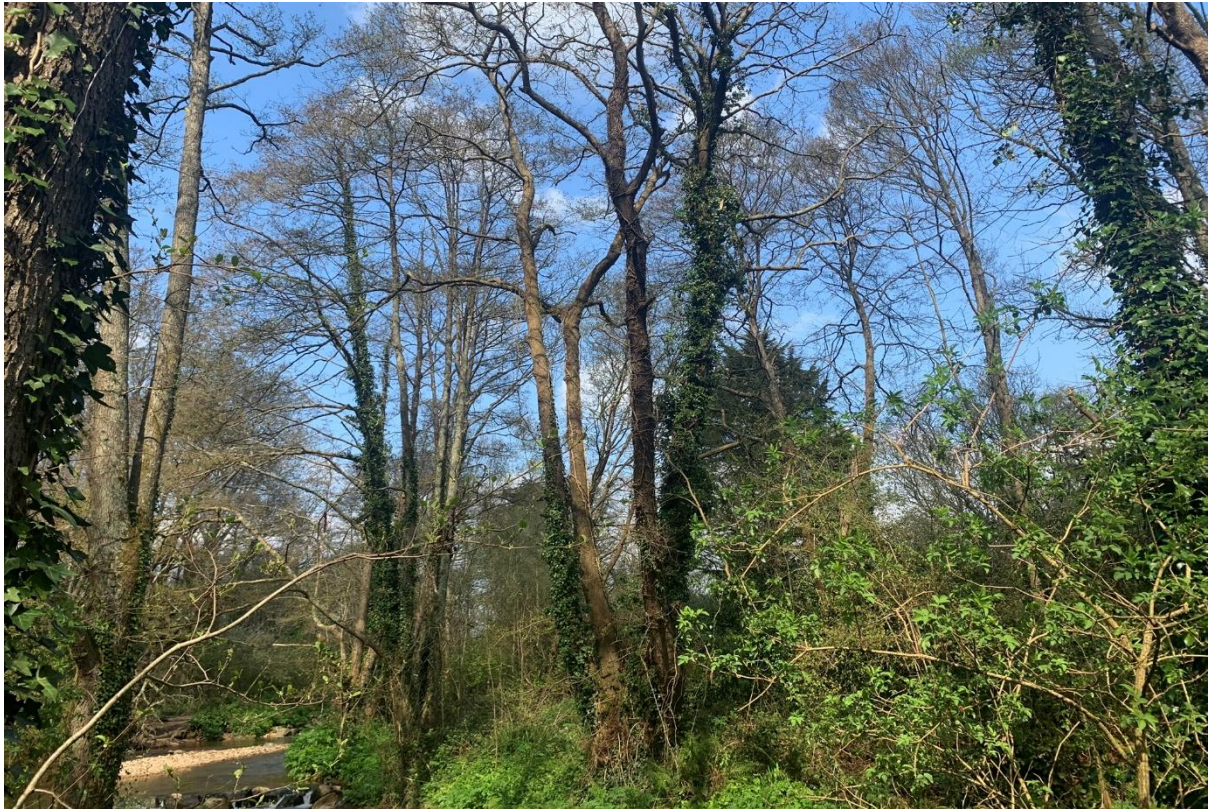
Figure 3: Mautre bankside trees are heavily shading the river, limiting primary productivity and marginal diversity. Felling a few carefully selected alders into the river (and securing as cabled kickers) would greatly increase river geomorphology and create some much-needed habitat diversity, but also increase light levels.

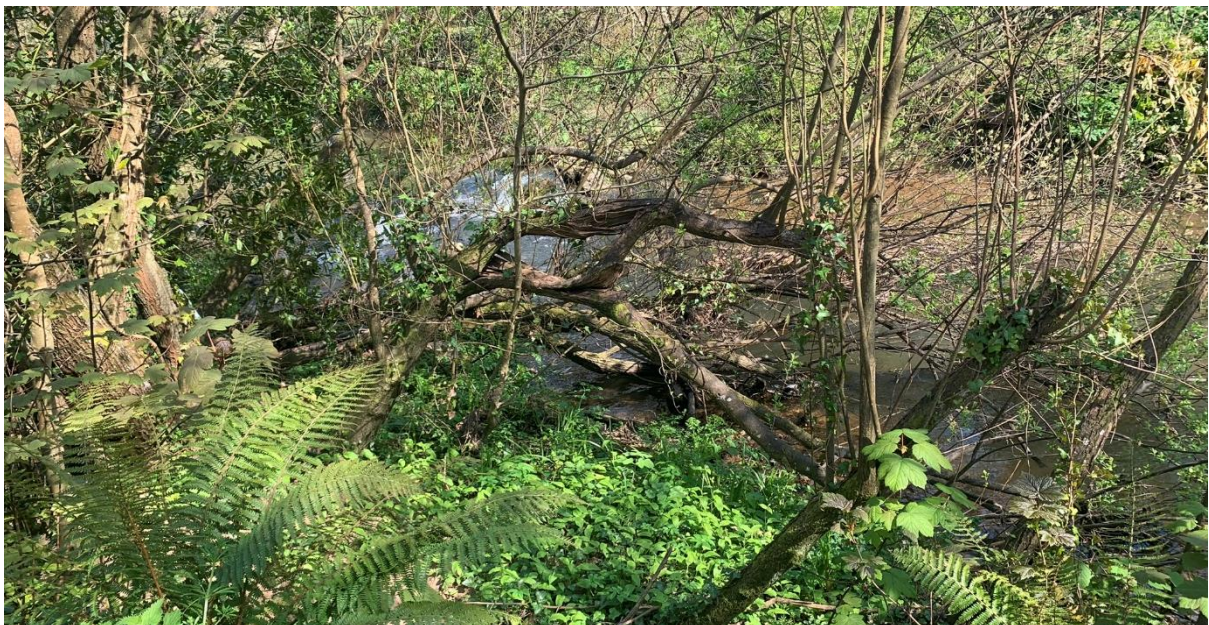
Figure 4: Bankside willows could easily be hinged cut and laid into the river downstream whilst still remaining firmly attached to their roots (these too, can be cabled as a redundancy). This would provide excellent marginal cover habitat and flow deflection whilst also keeping the tree alive and secure.

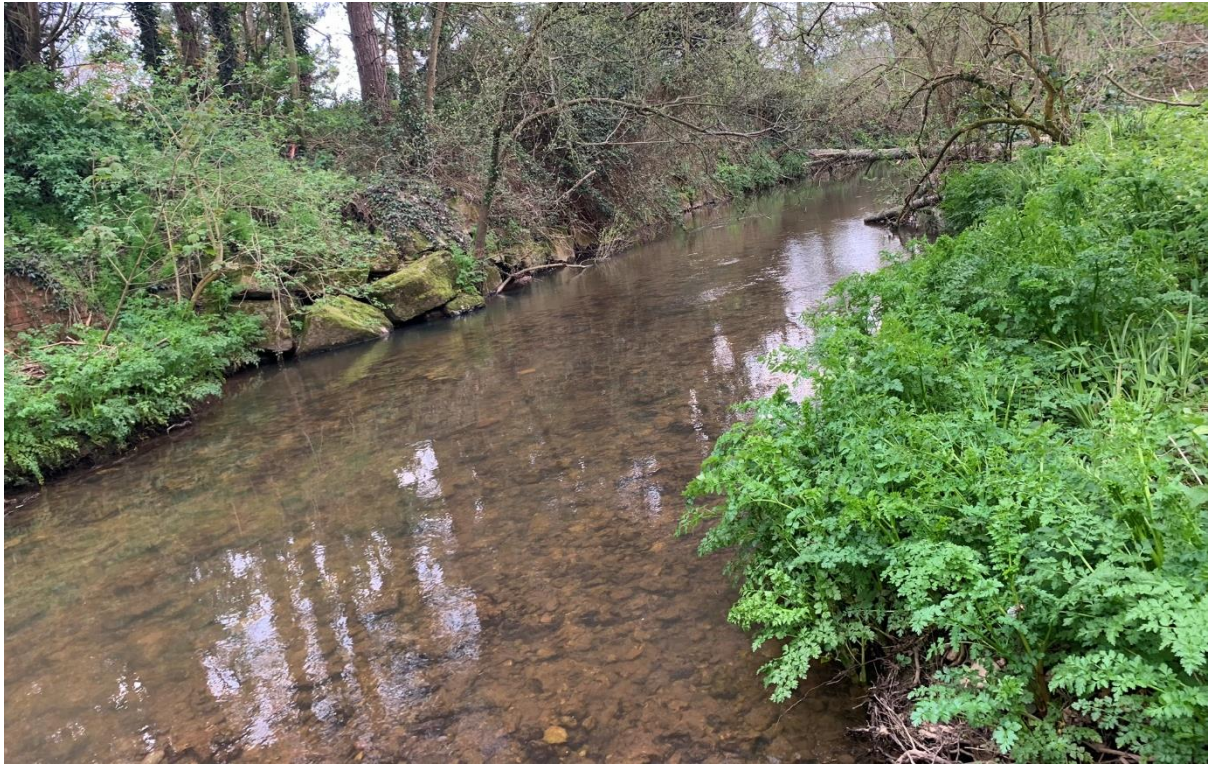
Figure 5: The riverbed profile is uniform and offers little diversity. The LB is still armoured with large boulders, providing minimal habitat diversity. Mature alder trees again, are casting a dense shade over the river.

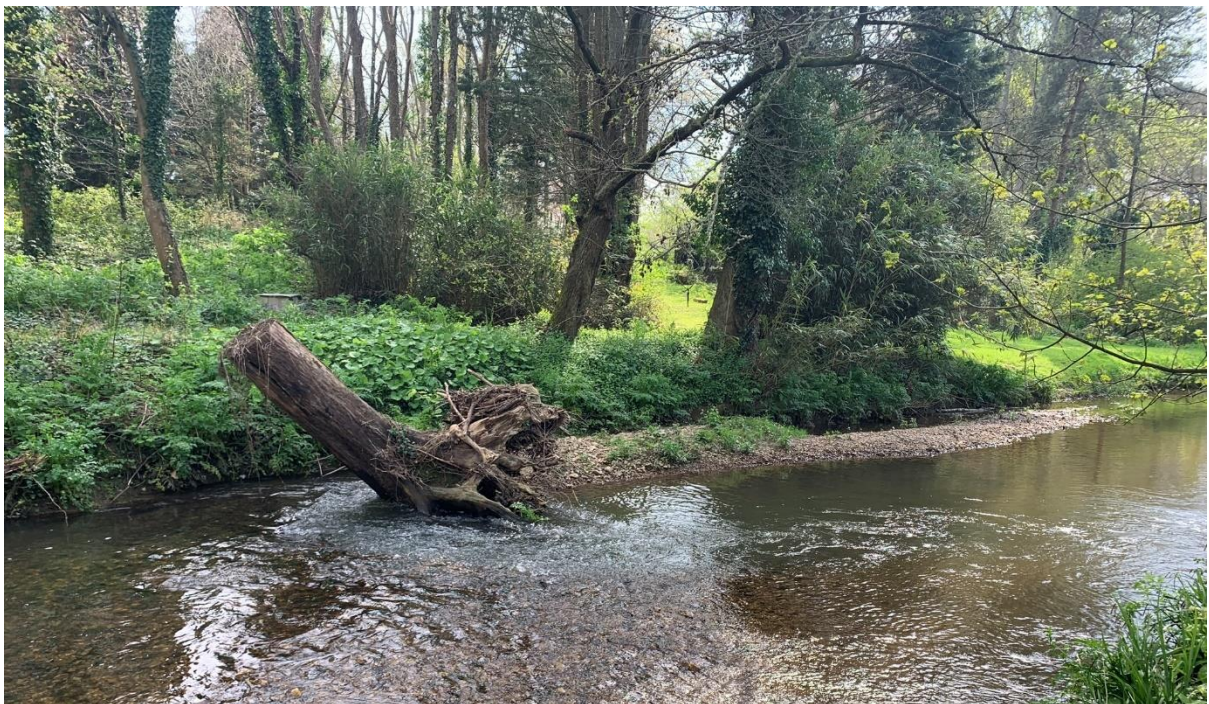
Figure 6: An example of natural LWM. Localised scour off this natural feature has carved out a deep pool and the flow deflection has allowed a gravel bar to form in the lee of the LWM. This is an excellent example of how simple interventions, like installing LWM can have a big effect on habitat locally.

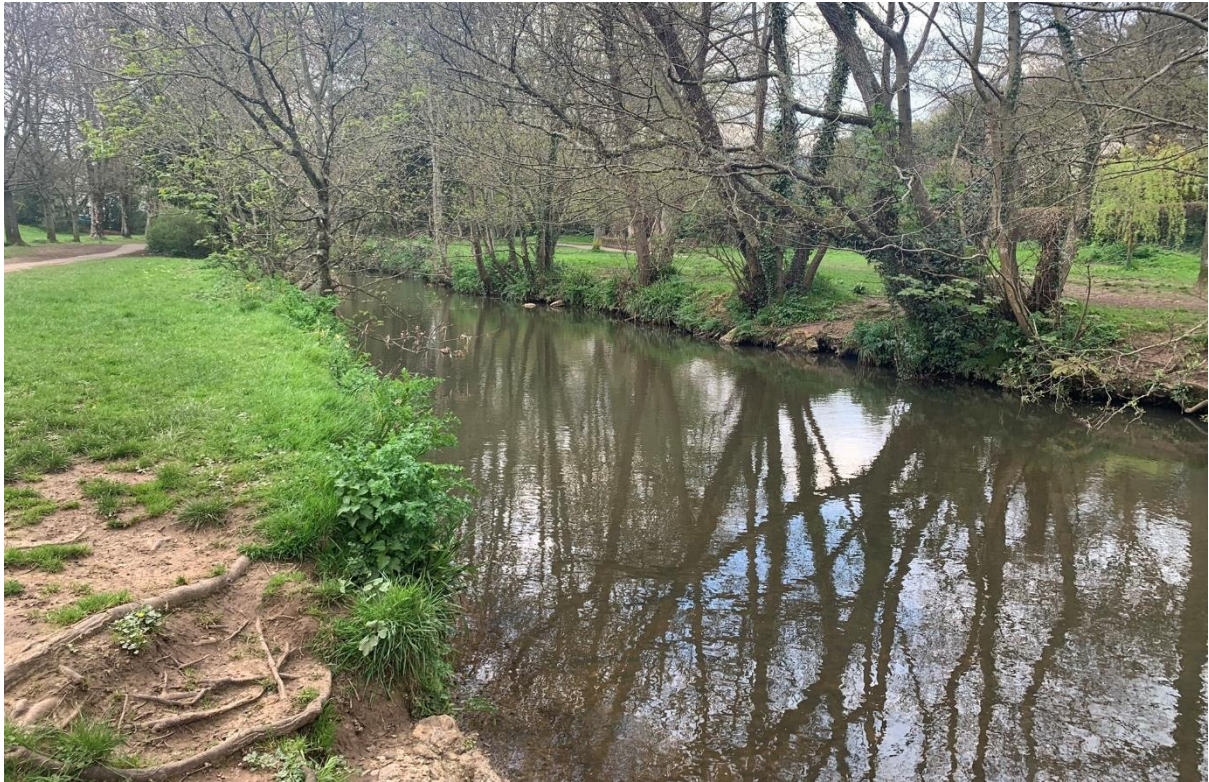
Figure 7: The River Sid towards the downstream extent of the reach inspected. Again, uniformly straight and lacking physical diversity and habitat.

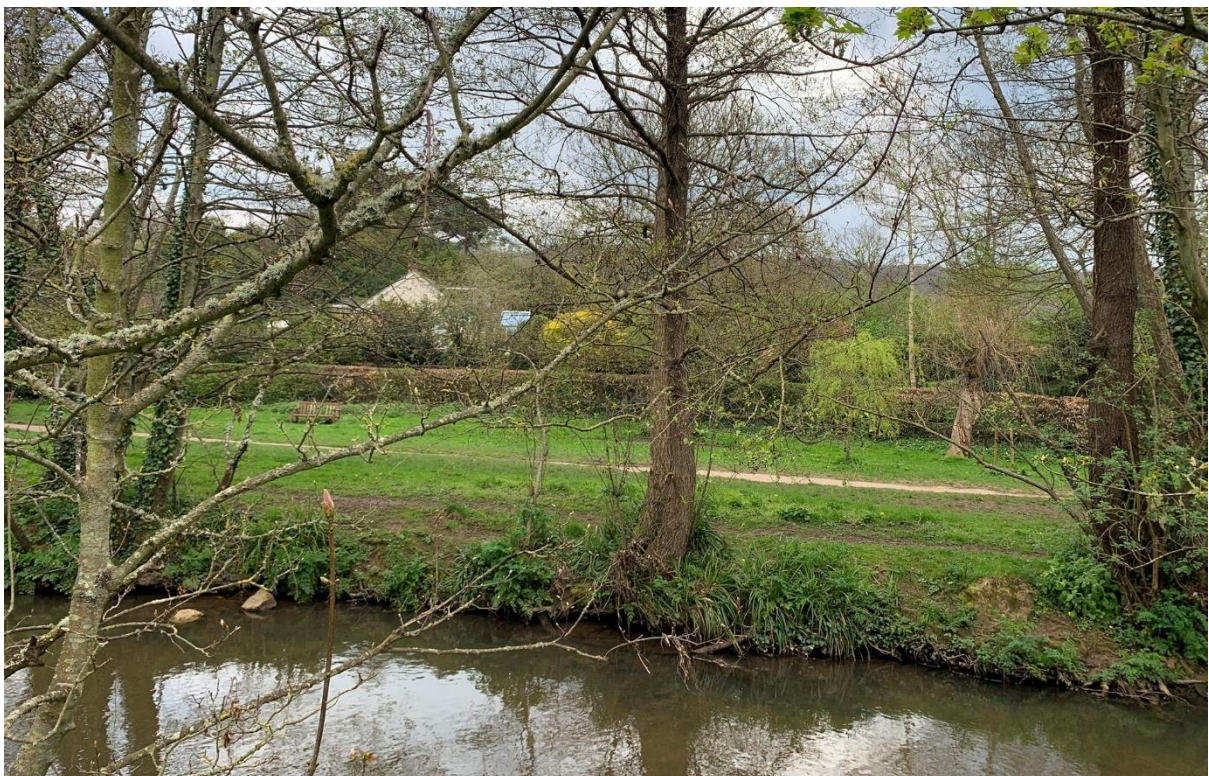
Figure 8: The riparian trees in the Byes waterside park have a greater amenity value, limiting the scope for habitat works. There is one low value alder tree that could be used to create a tree kicker to improve habitat. In a location with high public footfall, this single tree kicker would help educate locals about the river and could promote enthusiasm for more habitat works in the catchment.

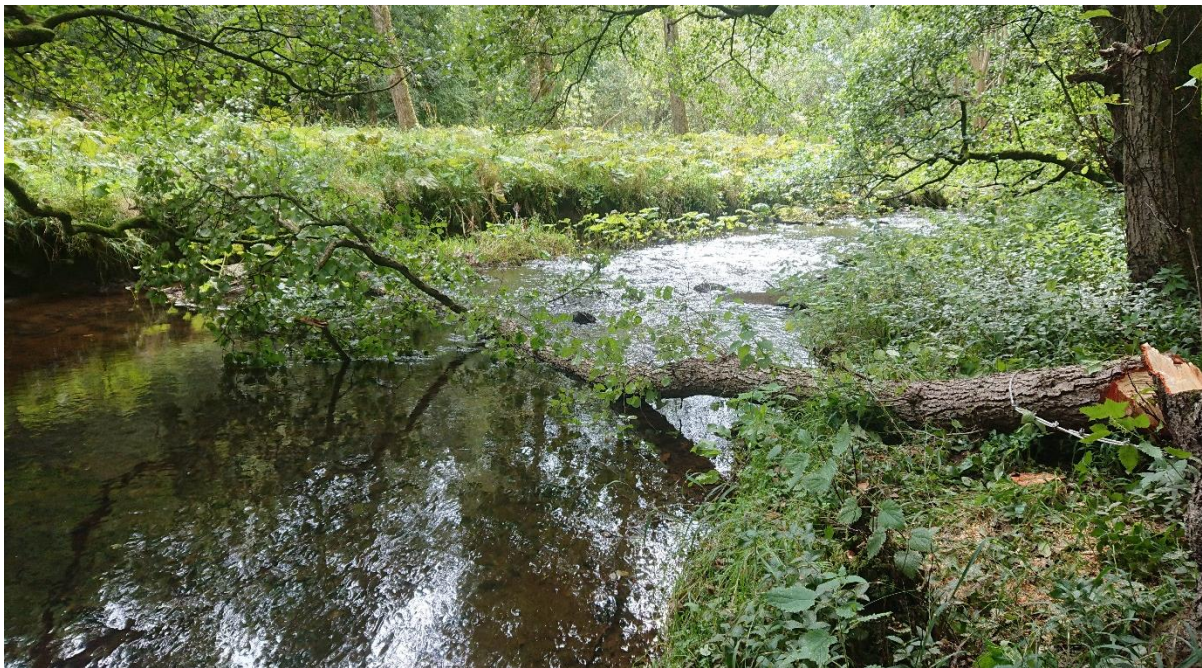
Figure 9: An example of an alder tree kicker on the Flasby Beck, with steel rope used to secure the felled tree to its stump.

Entire trees can be hinged and/or felled into the river and repositioned into the margins using a winch. Once in the desired position the hinged/felled tree is then secured back to its bankside stump. The width of the structure will be no more than 30% of the channel. A chainsaw or augur is used to bore a hole through the felled/hinged stem and the stump, then steel cable (12mm approx. 9.4 tonne b.s.) is fed through the holes in the stem and stump and steel cable clamps used to secure the kicker in place. This provides valuable in-stream woody habitat that is extremely resistant to spate flows, however, some branches may have to be trimmed after securing to allow high flows to pass over. The length of the cable must be set so that flow will naturally push the limb out of the main current during spate flow conditions but not so long that the limb can be lifted out of the channel during flood flows.

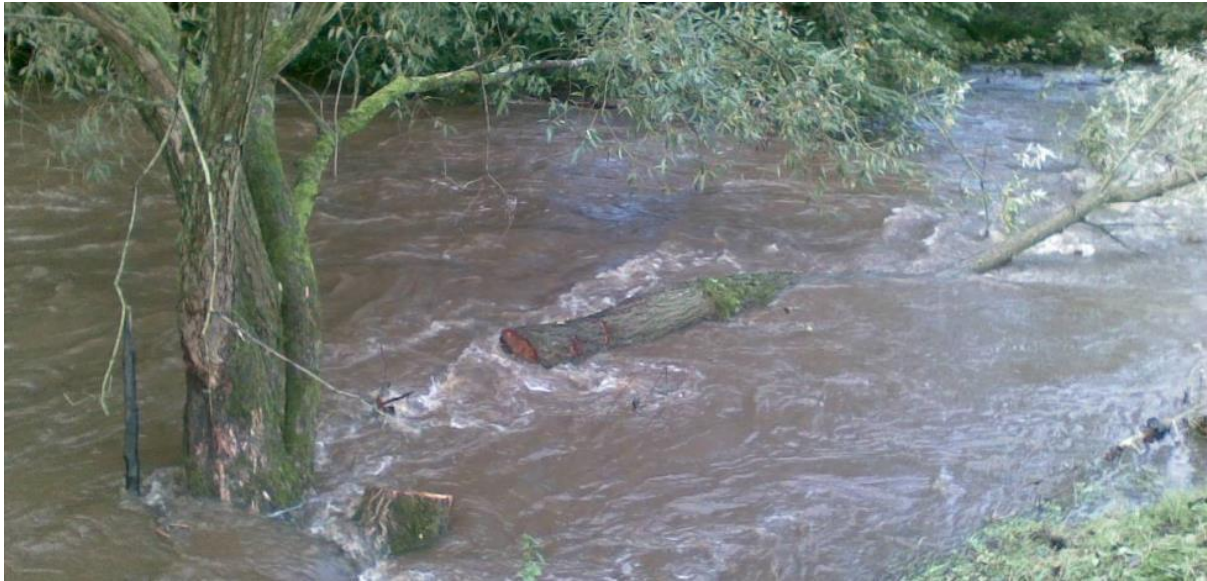
Figure 10: A cabled tree kicker in high flows. The cable allows the limb to move out of the main flow during spate conditions.

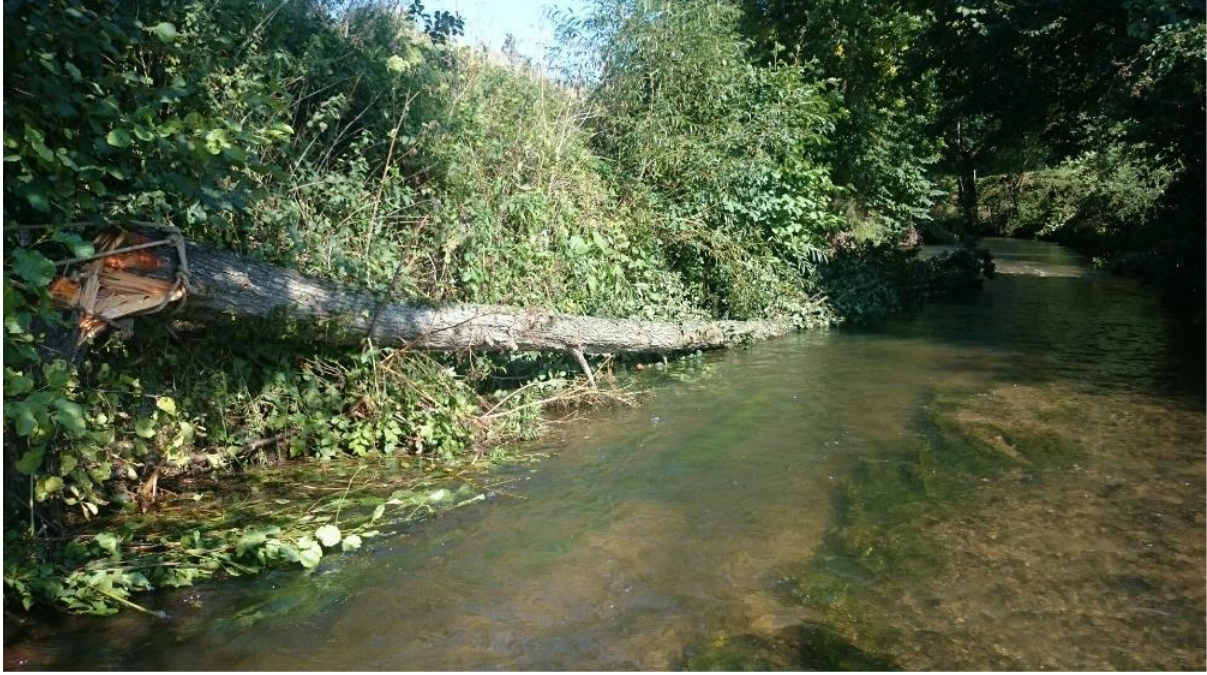
Figure 10: An example of a hinged alder tree laid into the margins of a spate river. Rope has been used to secure the tree as a redundancy, however steel wire may also be used where there is greater flood risk concerns.

In many cases, the hinge holding the felled tree or limb will be sufficiently strong to withstand spate flows but a variety of techniques are available to introduce additional security to the feature or provide a secure 'back up' as a redundancy should the hinge fail (Figure 10).

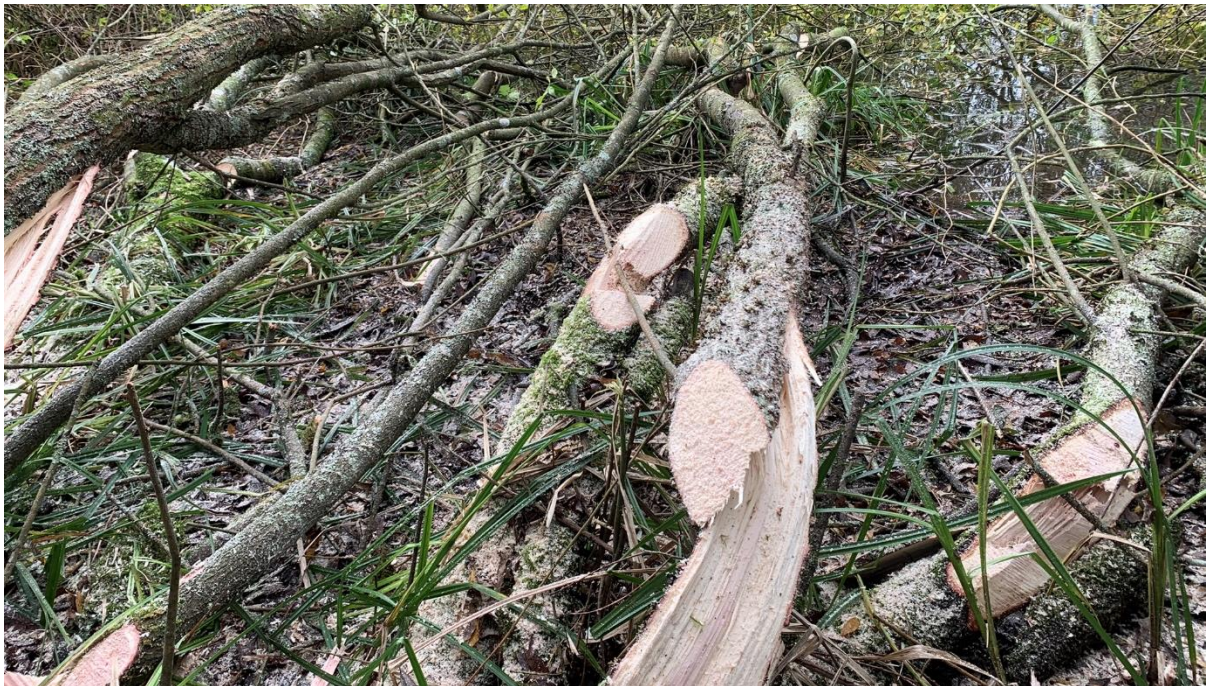
Figure 11: An example of hinging willow trees on the River Test.

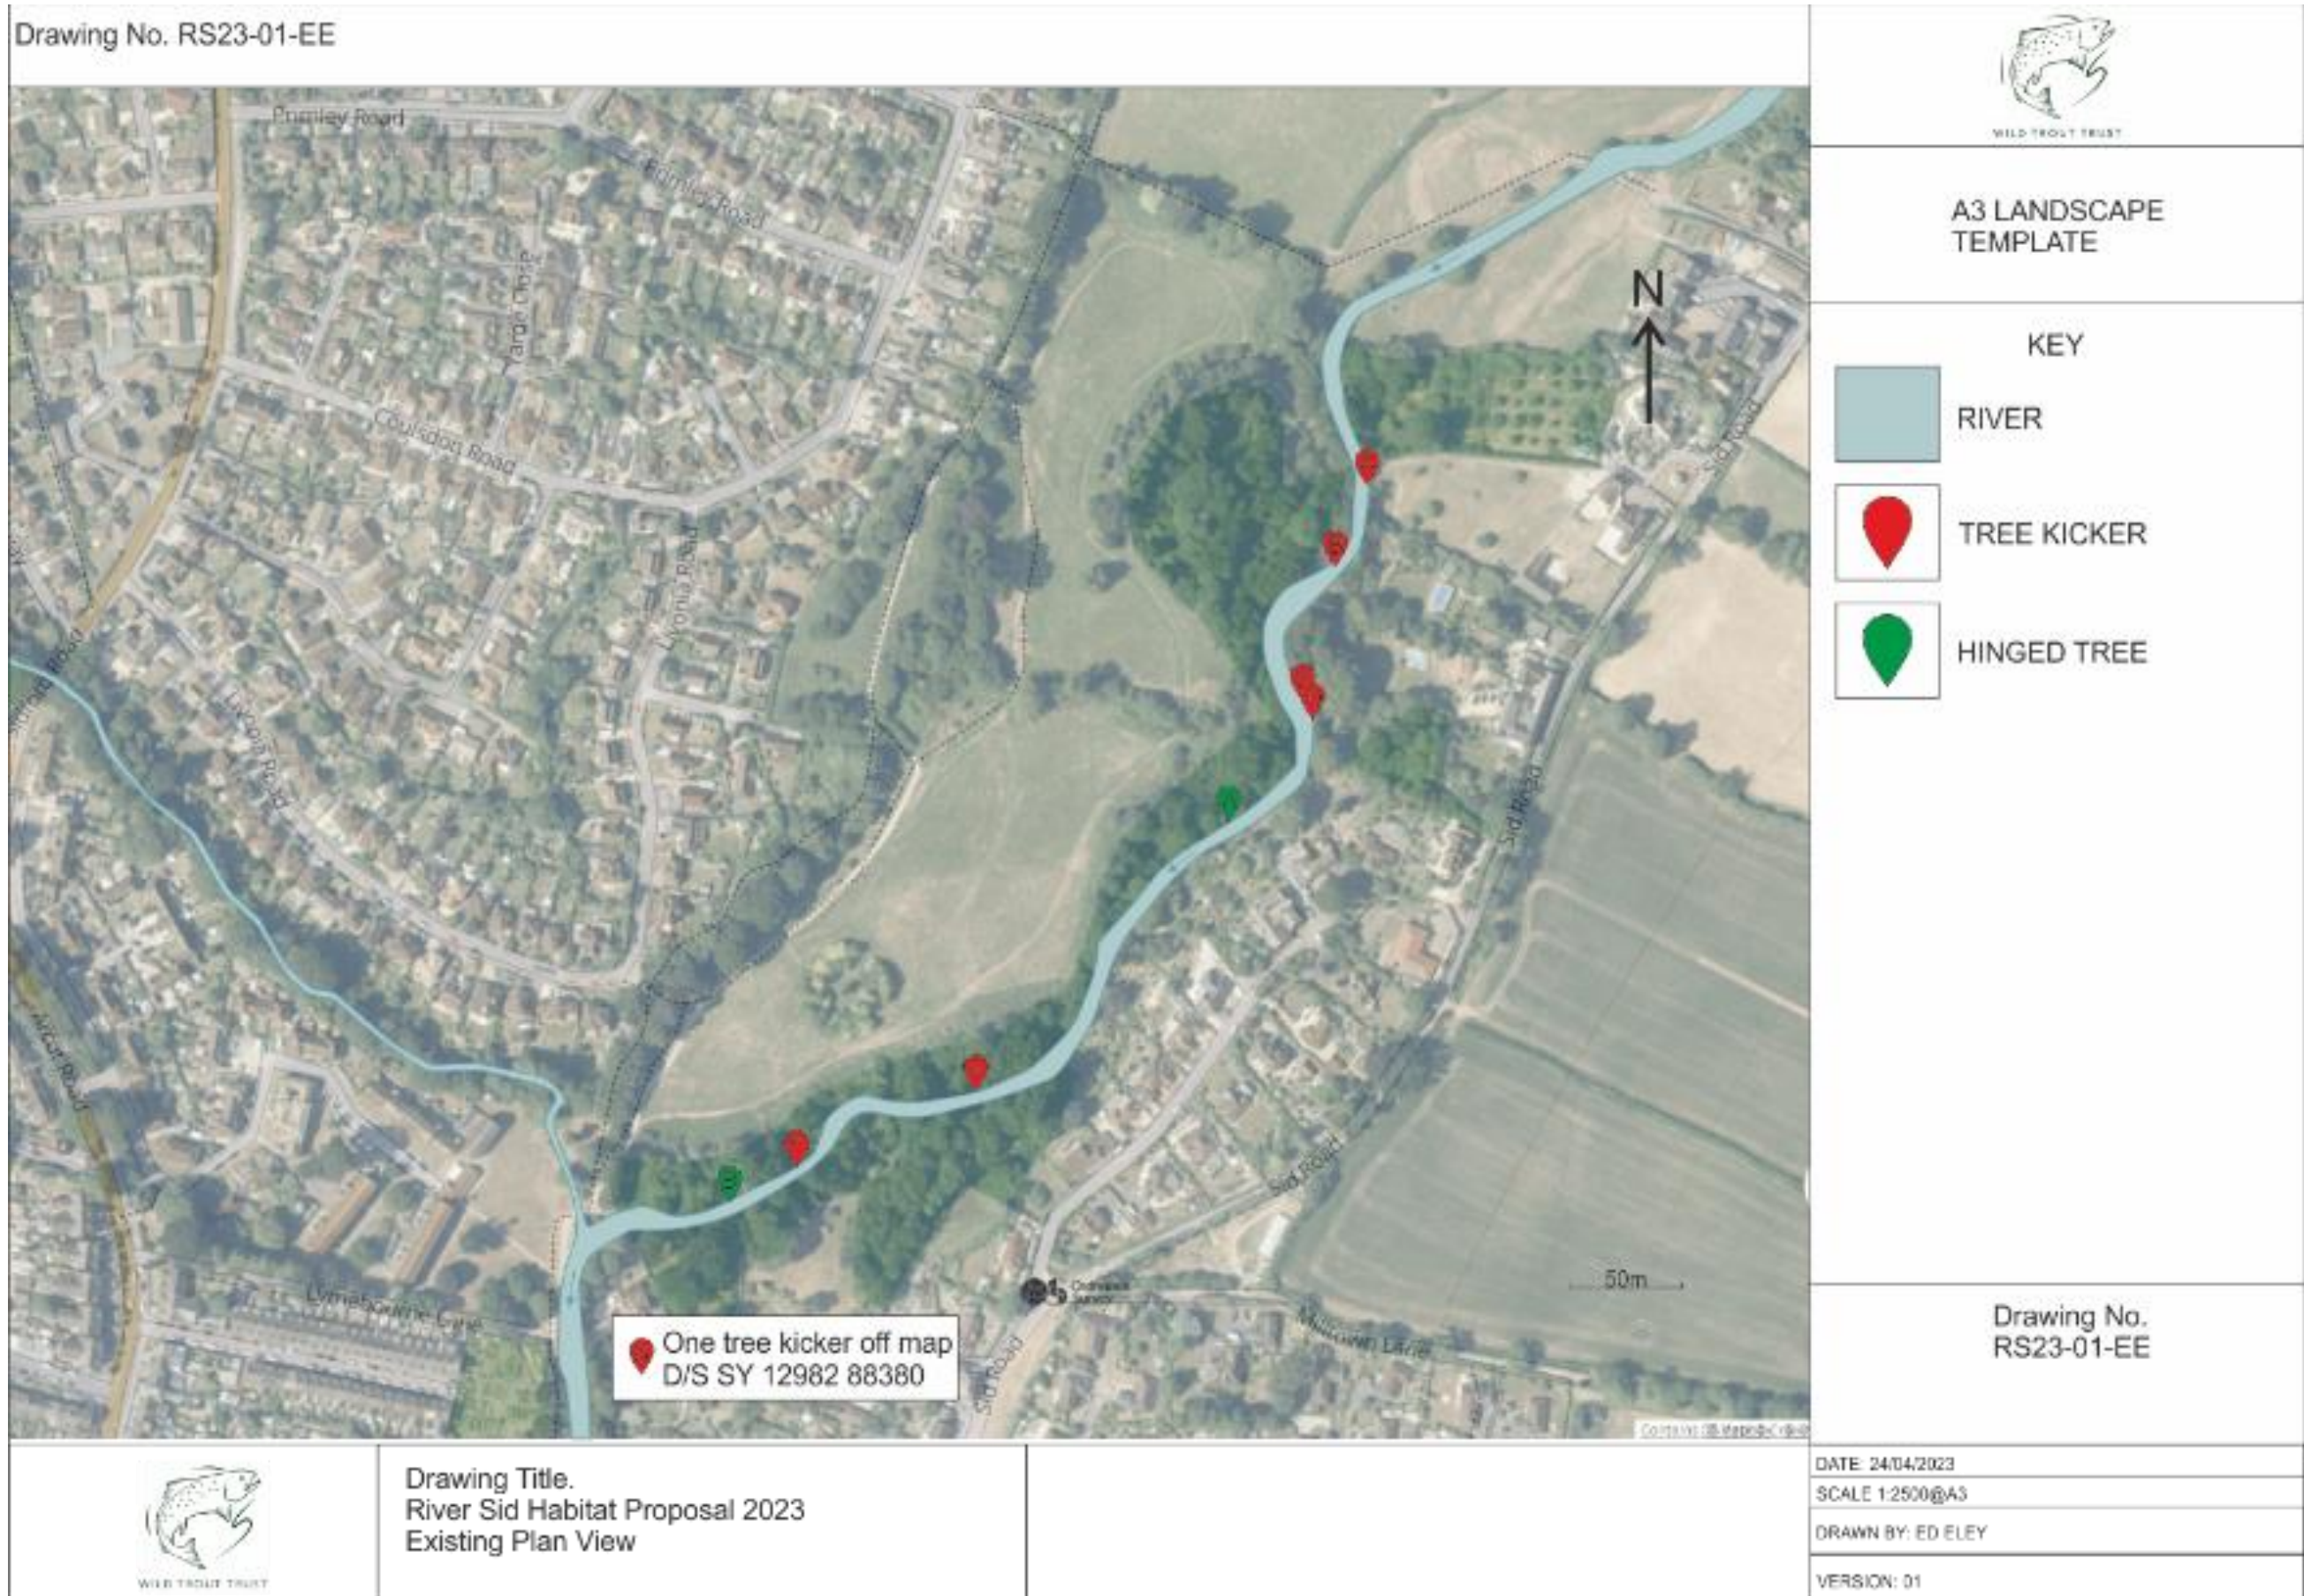
Appendix I: Proposed Plan View

Seven trees have been identified as suitable candidates to fell into the river and secure as cabled tree kickers and two small willow trees earmarked to be hinged D/S into the river margins (See Appendix I for proposed plan view map).

Fortunately, an abundance of bankside trees give rise to the opportunity to enhance flow diversity and reinvigorate natural geomorphological processes. Habitat quality in this reach would greatly benefit from the introduction of hinged and/or felled and secured tree kicker features (Appendix II proposed plan view).
