WILD TROUT TRUST  
wildtrout.org

## Advisory Visit River Sid, Devon

April 19, 2021

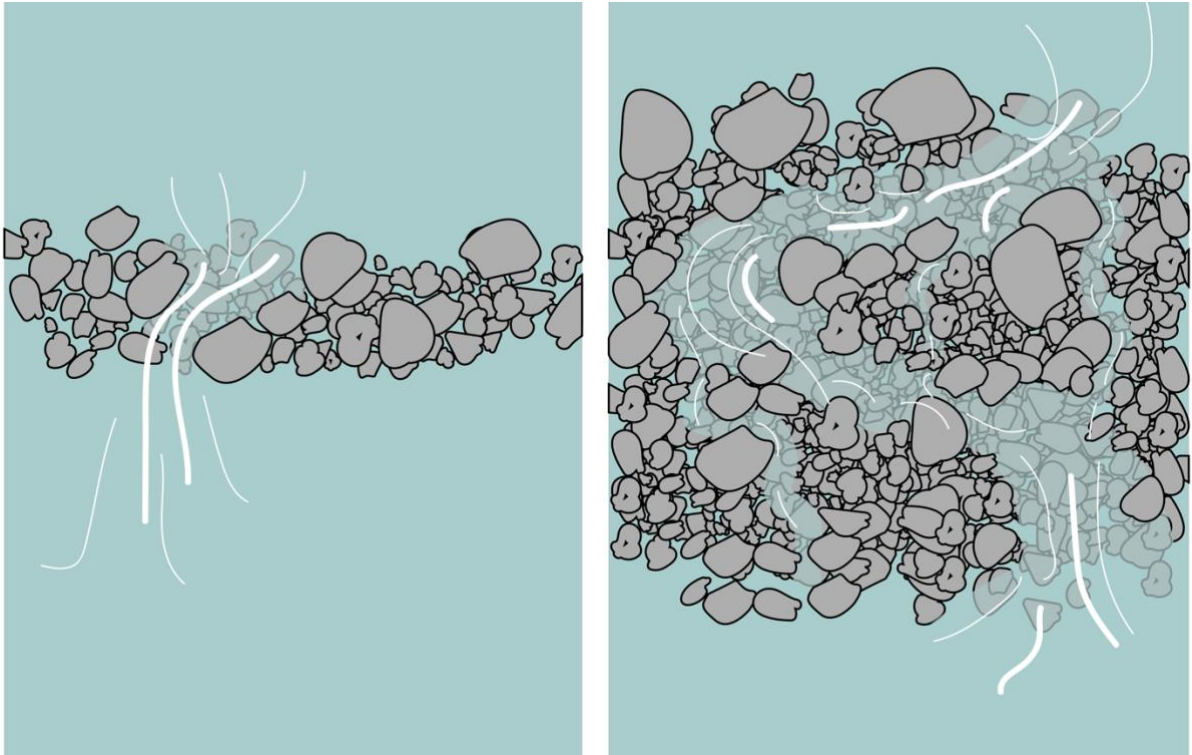
*Figure 23 A rough illustration of an existing boulder weir on the left, and a better design on the right with enforced lateral movement and a greater range of low flow pathways. Winching larger boulders (see appendix) up and downstream, in combination with lifting medium sized rocks will begin the process. High flows will move the smaller sized gravels and cobbles into the interstices completing the structure.*

With such an incised channel, lateral movement is difficult. Where the constraints of the channel are limiting such movement, repositioning the boulders to swing the stream from one side to the other will produce some of the desired effect, but needs to be done with care as bank erosion could occur in undesirable places such as riverside gardens.

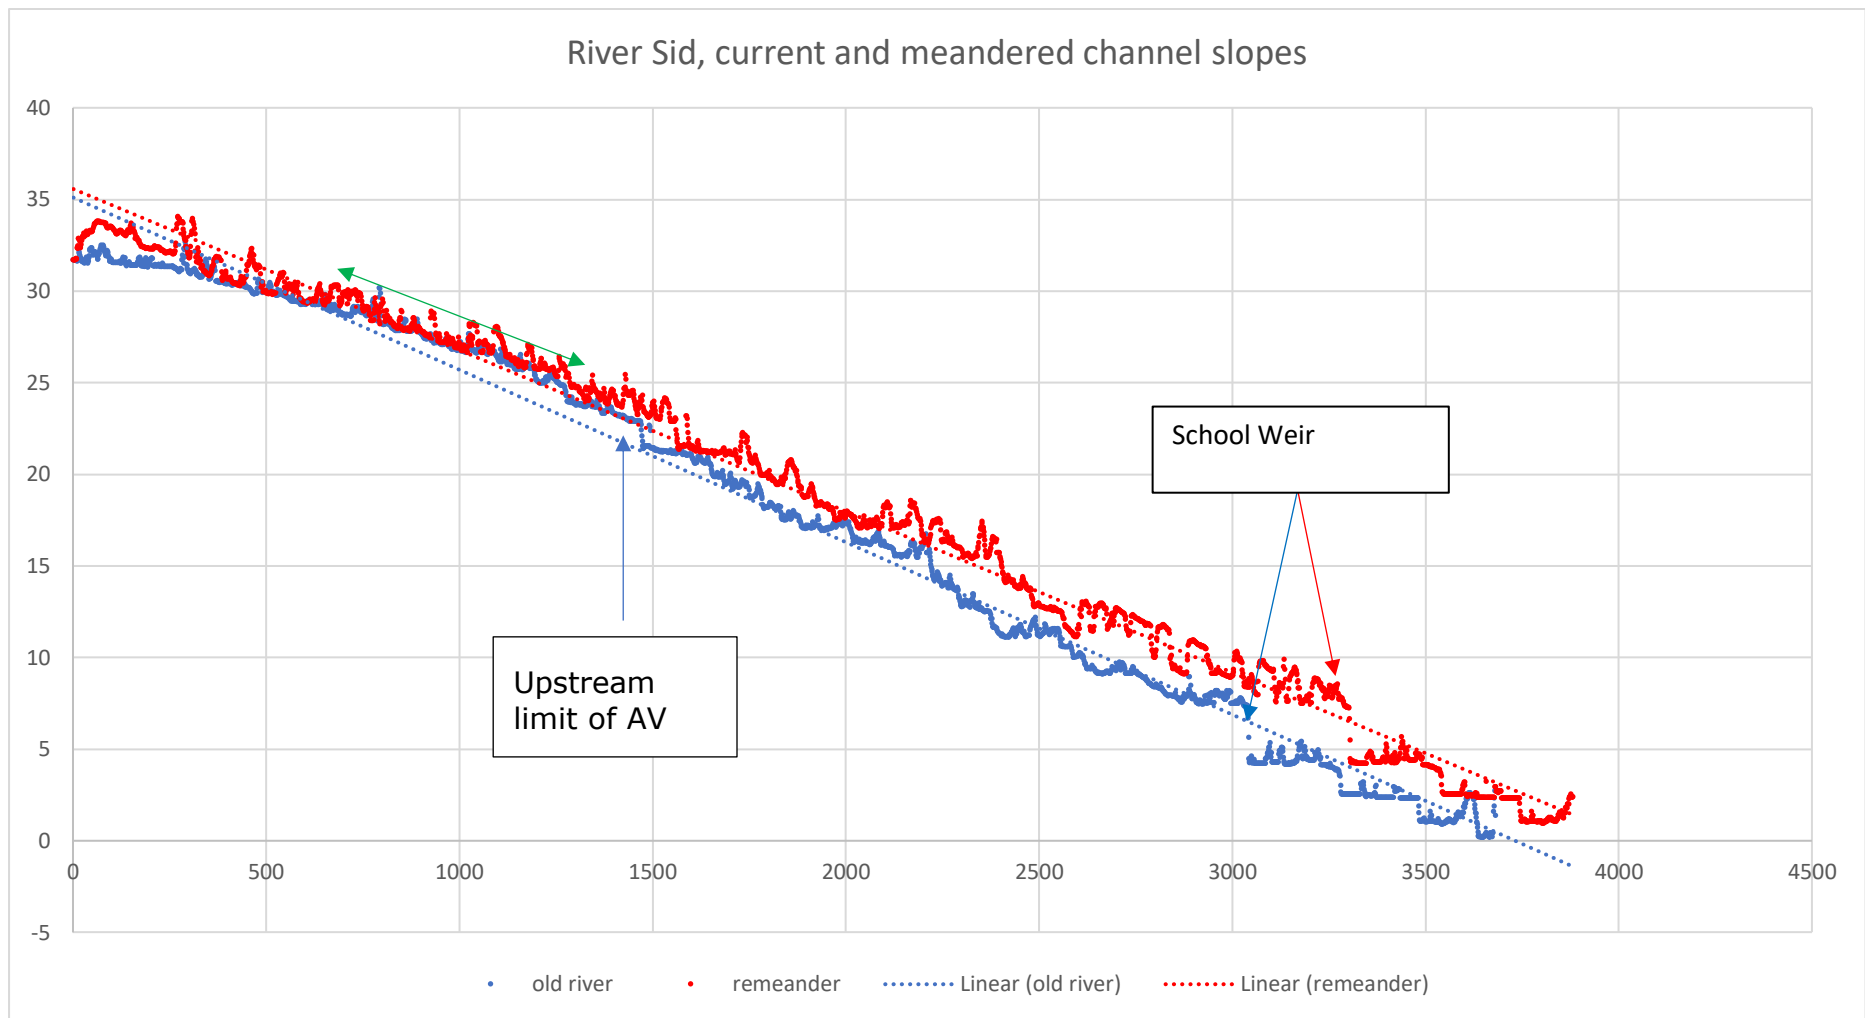
Chart 1 The slope of the current channel (blue) and a conceptual meandered channel (red). The current gradient increases noticeably at 1500m, whereas the new channel maintains an average gradient throughout. Note the green arrows which roughly indicates the meandering channel above the reach inspected Shown in Map 2. Its current gradient is broadly similar to the meandered channel. Also the number of flat sections to the current river, that indicate the areas of impoundment caused by weirs. The noise in the red is caused by the meander form picking up spot heights from the higher river bank.

With the current course, from Sidbury to the sea, having an approximate gradient of 1 in 100 re-meandering could reduce this by approximately 7% but the measures to establish this will also increase hydraulic roughness, further decreasing discharge (Chart 1). As such, allowing lateral erosion will have a net benefit to flow reduction, habitat value and slowing the bed erosion.

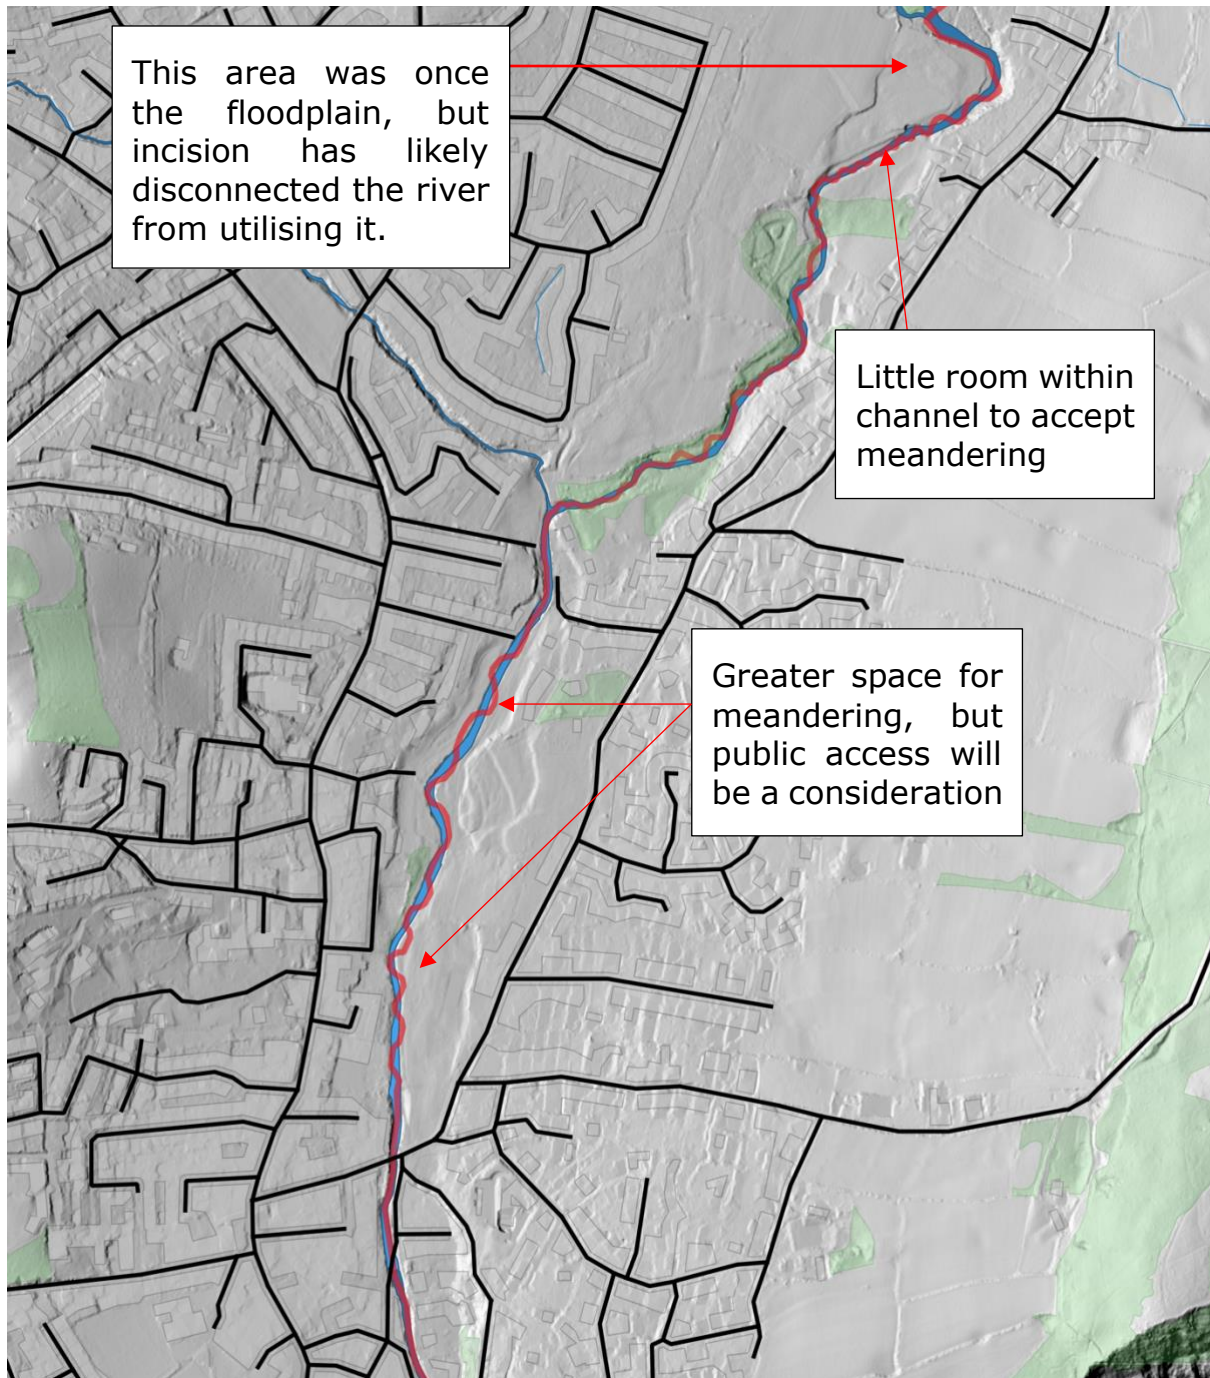
Map 2 The current straightened course of the channel (blue) and a conceptual meandering course (red). Spot heights taken from LiDAR data constructed the chart above.

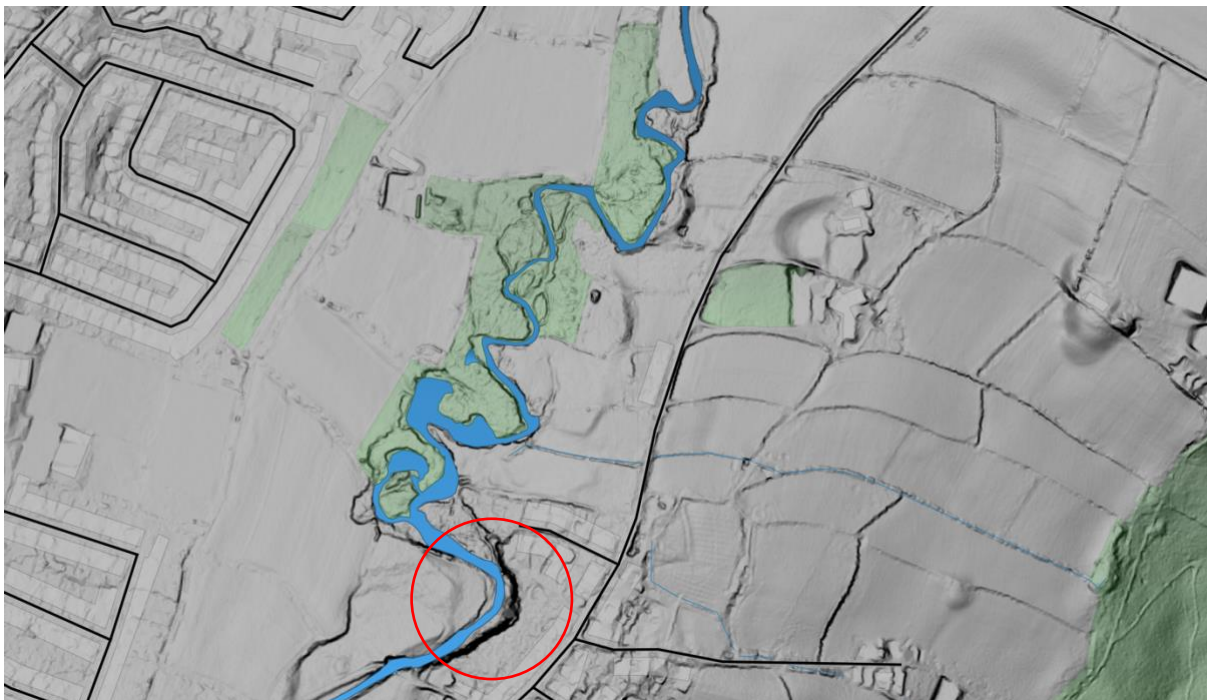
*Map 3 A LiDAR map of the naturally meandering river above the reach inspected. Such an unconstrained, meandering planform is to be aimed for. Clear evidence of recent paleochannels can be seen, showing the river's ability to re-route itself and fully access its flood plain: all things essential for good river function. Note the steepness of the channel sides (red circle) where straightening downstream has begun to take effect, causing bed erosion and incision.*
